**3rd EYE HOME INSPECTION, LLC Inspection Report**

Client(s): **SAMPLE REPORT 1**

Property address: **1212 Mocking Bird Ln, GA**

Inspection date: **Tuesday, June 2, 2020**

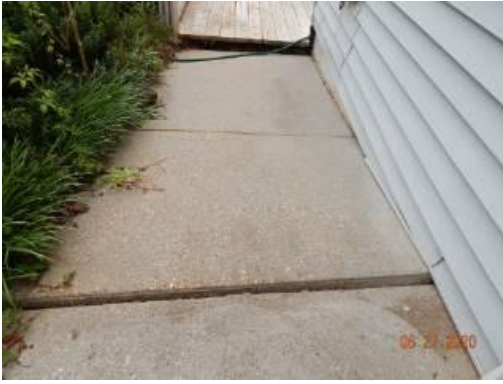
Photo 2-1

Cracks, holes, settlement, heaving and/or deterioration resulting in trip hazards were found in the sidewalks or patios. For safety reasons, recommend that a qualified contractor repair as necessary to eliminate trip hazards.

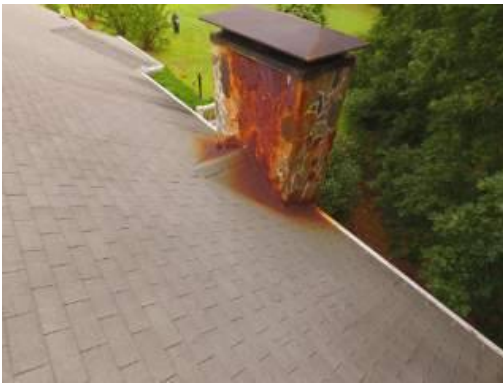
Photo 3-1

Vegetation such as trees, shrubs and/or vines was in contact with or less than 10 feet from one or more chimney or flue outlets. This is a safety hazard due to the risk of fire. Vegetation should be pruned and/or removed as necessary to maintain a 10 foot clearance between it and all chimney or flue outlets.

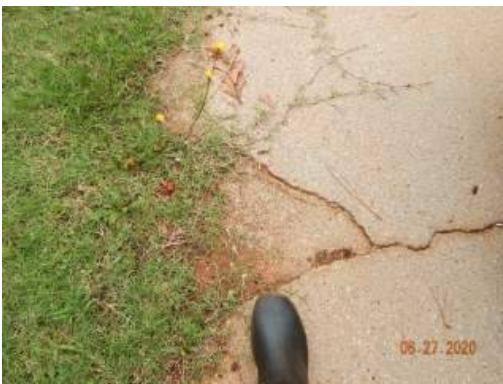
Photo 4-1

Cracks, holes, settlement, heaving and/or deterioration were found in the driveway. Recommend that qualified contractor repair as necessary.

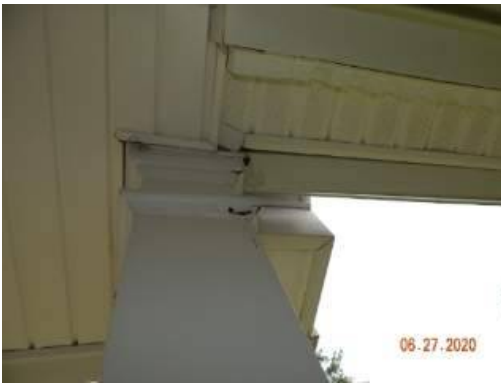
Photo 5-1

5) 🪛 Fungal rot was found in support posts at one or more structures covering decks, patios and/or porches. Recommend that a qualified person repair as necessary. All rotten wood should be replaced.

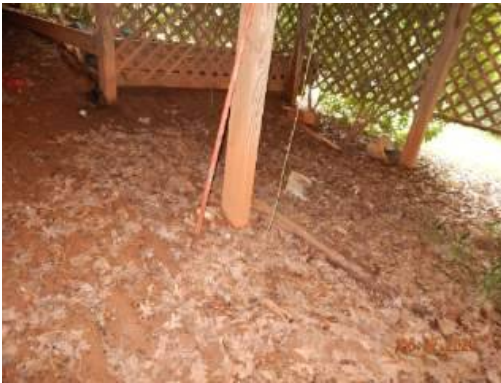
Photo 6-1

6) 🚧 Soil was in contact with one or more wooden deck, porch or balcony support posts. This is a conducive condition for wood destroying organisms. Even if posts are made of treated wood, the cut ends below soil may not have been field treated. Recommend grading soil or repairing as necessary to prevent wood-soil contact.

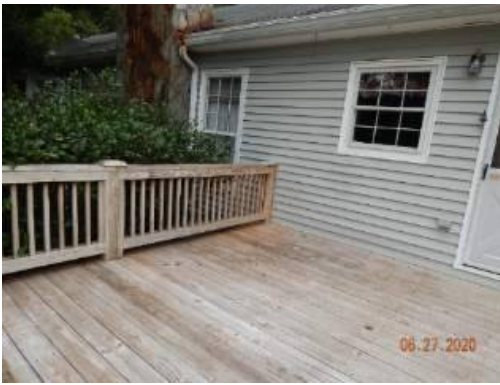
Photo 7-5

Resurfacing paint on one or more decks, porches or balconies was peeling and failing. This type of coating is similar to extremely thick paint and is designed to mask wood and fill large cracks or voids. Such products include Behr Deckover, Olympic Rescue-It, Rust-Oleum Deck Restore, Cabot Deck Correct and Pittsburgh Revitalize. Peeling can be an issue for any film-forming coating, but many reports of peeling have been made regarding these thick resurfacing paints. Once this type of coating begins to fail, repairing the coating may be difficult, or not work. Removal of this coating in order to apply a different finish can be very difficult. Recommend consulting with a qualified painting contractor to determine what repairs or maintenance are needed. For more information, visit:

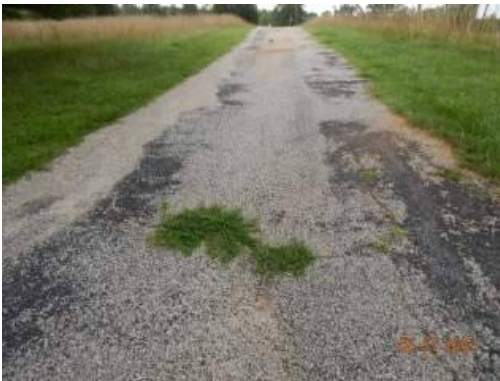
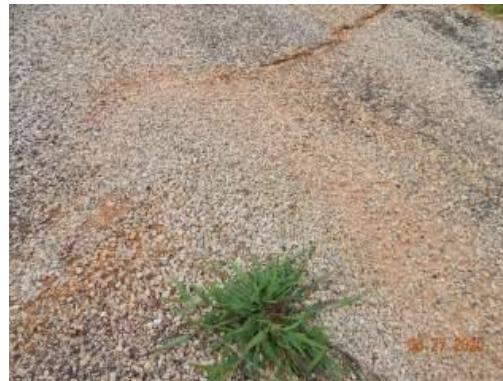
8) The driveway had significant growth of moss or vegetation. Recommend cleaning or removing growth to prevent deterioration.

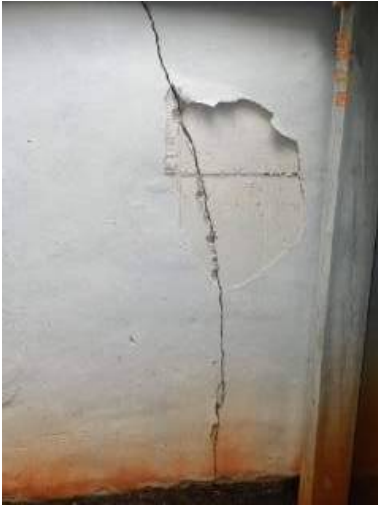
Photo 9-1

9) Major cracks (more than 3/4-inch wide) and/or leaning was found in the foundation. These appear to be a structural concern and may indicate that settlement is ongoing. Recommend hiring qualified contractors and/or engineers as necessary for further evaluation. Such contractors may include:

- Foundation repair contractors who may prescribe repairs, and will give cost estimates for such repairs
- Masonry contractors who repair and/or replace brick veneer
- Geotechnical engineers who attempt to determine if settlement is ongoing, and the cause of the settlement
- Structural engineers who determine if repairs are necessary, and prescribe those repairs

Repairs should be made by a qualified contractor.

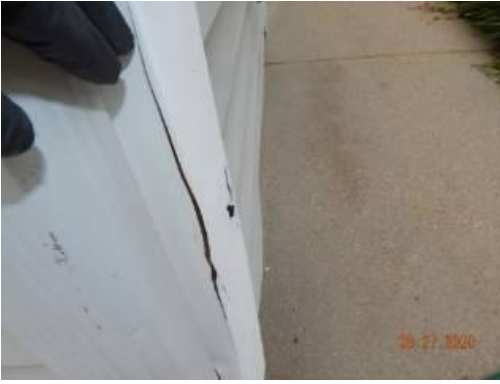
**Photo 10-1**

Some sections of siding and/or trim were damaged. Recommend that a qualified person repair, replace or install siding or trim as necessary.

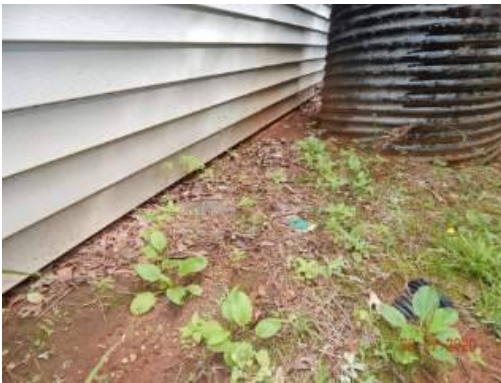
**Photo 12-1**

Soil was in contact with or less than 6 inches from siding or trim. Regardless of what material is used for siding, it should not be in contact with the soil. If made of wood, siding or trim will eventually rot. For other materials, ground or surface water can infiltrate siding or trim and cause damage to the wall structure. Wood-destroying insects are likely to infest and damage the wall structure. This is a conducive condition for wood-destroying organisms. Recommend grading or removing soil as necessary to maintain a 6-inch clearance. Note that damage from fungal rot and/or insects may be found when soil is removed, and repairs may be necessary.

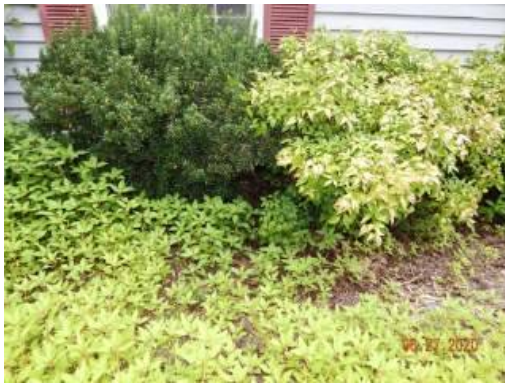
Photo 13-1

Vegetation such as trees, shrubs and/or vines was in contact with or close to the building exterior. Vegetation can serve as a pathway for wood-destroying insects and can retain moisture against the exterior after it rains. This is a conducive condition for wood-destroying organisms. Recommend pruning, moving or removing vegetation as necessary to maintain at least 6 inches of space between it and the building exterior. A 1-foot clearance is better.

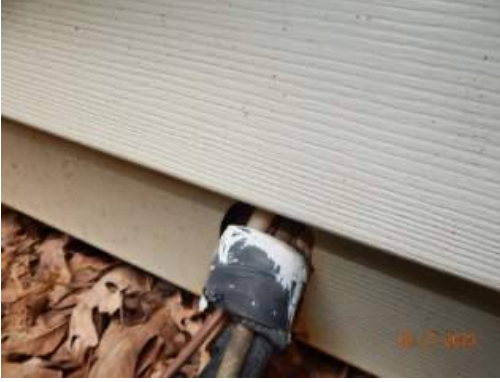
Photo 14-1

14) 🛠️Caulk was missing in some areas. For example, at siding-trim junctions and/or at wall penetrations. Recommend that a qualified person renew or install caulk as necessary. Where gaps are wider than 1/4 inch, an appropriate material other than caulk should be used. For more information, visit: <https://www.reporthost.com/?CAULK>

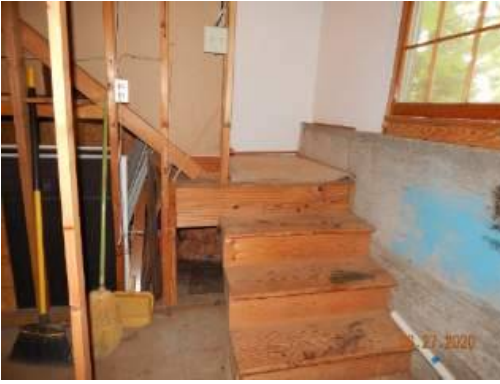
Photo 16-1

Handrails at one or more flights of stairs were missing. This is a potential fall hazard. Handrails should be installed at stairs with four or more risers or where stairs are greater than 30 inches high. Recommend that a qualified contractor install handrails where missing and per standard building practices.

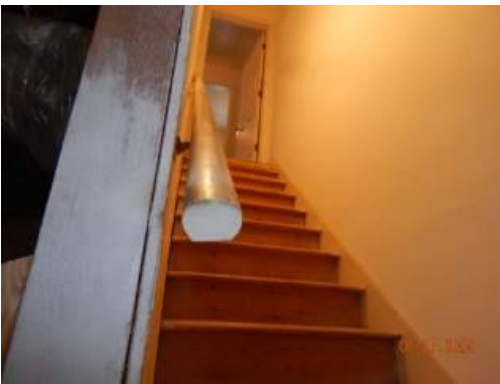
Photo 17-1

One or more handrails had no returns installed, where ends of handrails turn and connect to adjacent walls so objects or clothing will not catch on the open ends. This is a safety hazard. Recommend that a qualified person install returns per standard building practices.

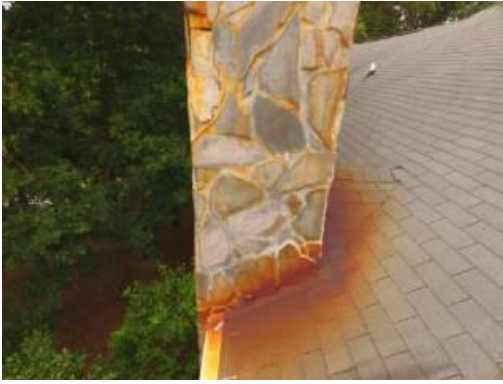
Photo 18-1

Flashings at the base of one or more chimneys were corroded. Leaks can occur as a result. This is a conducive condition for wood-destroying organisms. Recommend that a qualified contractor evaluate and repair as necessary.

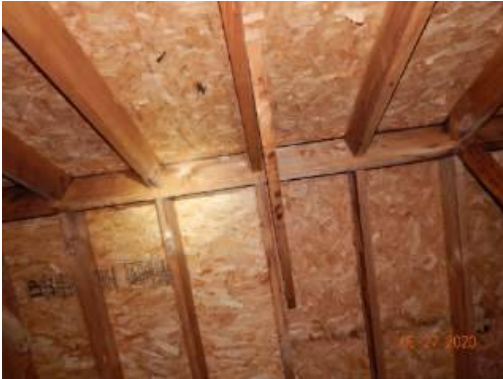
Photo 19-1

Observed one or more collar ties appeared to be disconnected from the rafter at the time of the inspection. Recommend having a qualified professional evaluate further and make any necessary repairs.

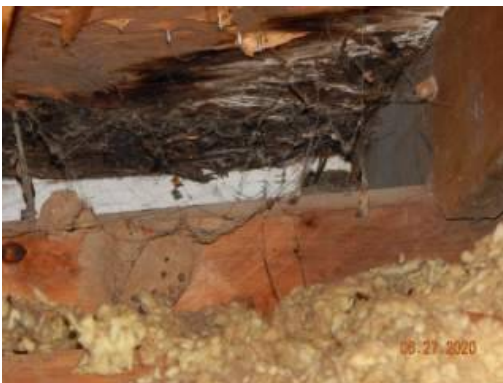
Photo 20-1

Fungal rot or significant water damage was found at one or more roof areas at edges of roof sheathing and/or fascia boards. Recommend that a qualified contractor repair as necessary. For example, by replacing all rotten wood, priming and painting new wood and installing flashing.

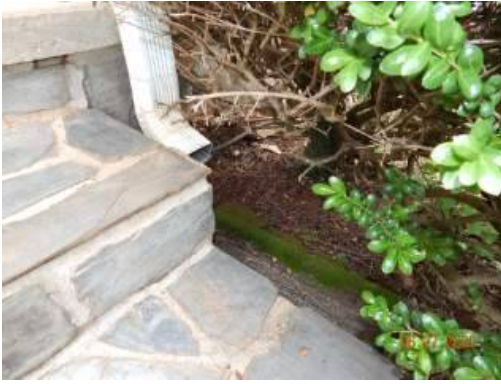
Photo 21-1

Extensions such as splash blocks or drain pipes for one or more downspouts were missing, poorly sloped and/or misaligned. Water can accumulate around the building foundation or inside crawl spaces or basements as a result. Recommend that a qualified person install, replace or repair extensions as necessary so rainwater drains away from the structure.

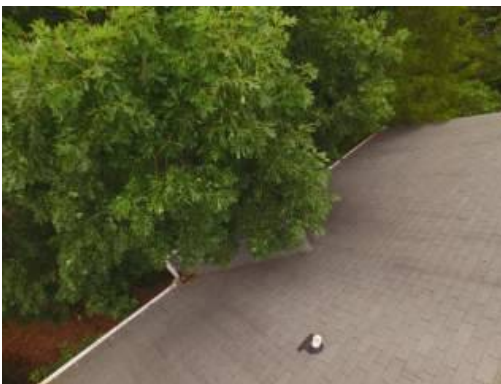
Photo 22-1

Vegetation such as trees, shrubs, and/or vines overhung the roof surface or were in contact with the roof edge. Organic debris such as leaves or needles are likely to accumulate in gutters and on the roof surface. Gutters can overflow and cause water to come in contact with the building exterior or water can accumulate around the foundation. This is a conducive condition for wood-destroying organisms. Vegetation in contact with the roof can damage the roof surface and/or the roof drainage system. Recommend pruning vegetation so as to not be in contact with the roof and to not overhang the roof surface. If vegetation is too tall then it should be pruned at least 10 feet above the roof surface.

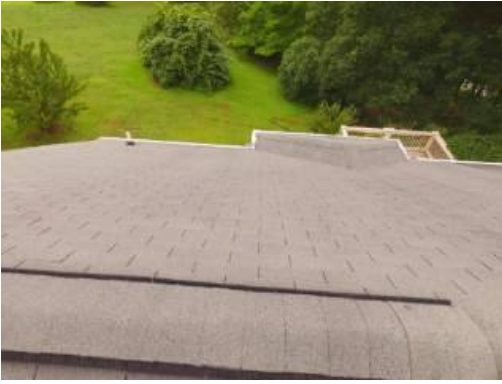
Photo 23-1

Nail heads were exposed at one or more shingles. More than just a few exposed nail heads may indicate a substandard roof installation. Recommend applying an approved sealant over exposed nail heads now and as necessary in the future to prevent leaks.

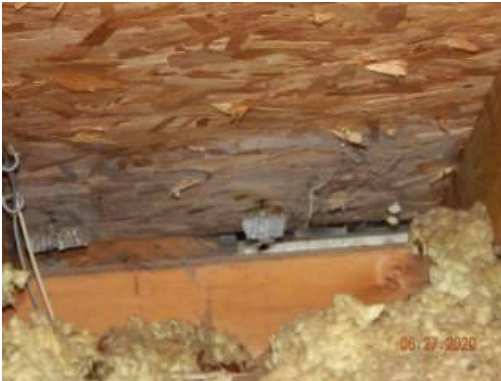
Photo 25-1

The roof structure in the attic was wet, and/or dripping water was found at one or more locations. There appeared to be one or more active leaks in the roof. Recommend that a qualified contractor evaluate and repair as necessary.

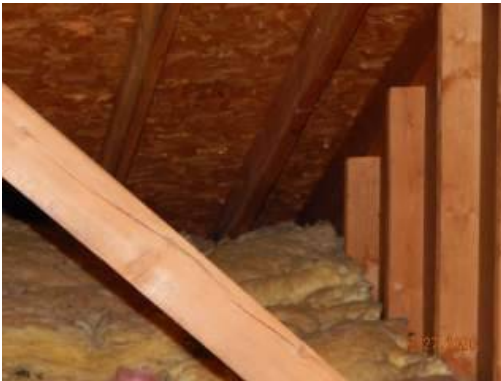
Photo 26-1

One or more rafters in the roof structure were damaged or split. This may significantly weaken the roof structure. Recommend that a qualified contractor repair as necessary.

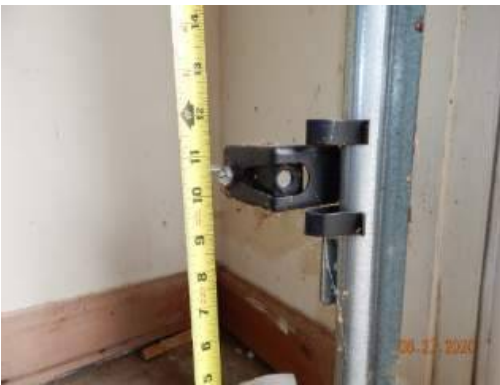
Photo 31-1

The photoelectric sensors that trigger the auto-reverse feature on one or more garage vehicle doors' automatic openers were located higher than 4-6 inches from the floor. This is a potential safety hazard. A qualified person should relocate sensors so they are 4-6 inches from the floor per standard building practices. For more information on garage door safety issues, visit:

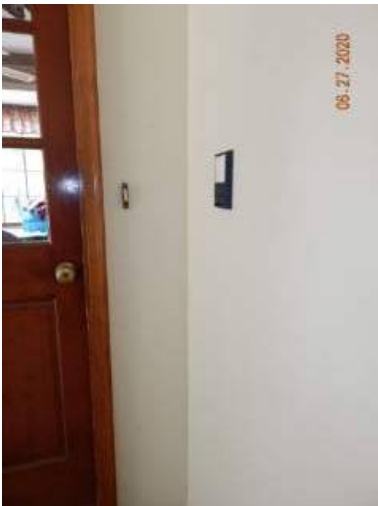
Photo 32-1

The wall-mounted control for one or more automatic garage vehicle door openers was less than 5 feet off the floor, or within reach of children. This is a safety hazard. Children should not be able to operate automatic garage vehicle door openers. A qualified person should relocate controls for door openers so they are at least 5 feet above floors and/or out of reach of children. For more information on garage door safety issues, visit:

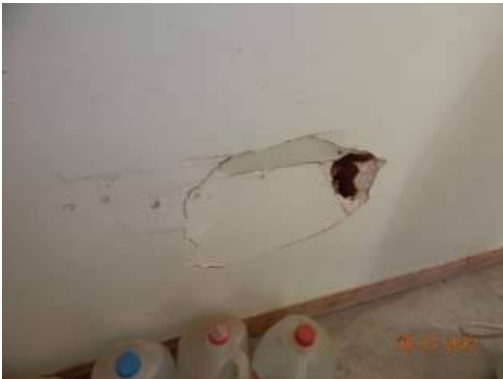
Photo 33-1

Observed one or more walls appeared damaged at the time of the inspection. Recommend have a qualified professional make the necessary repairs.

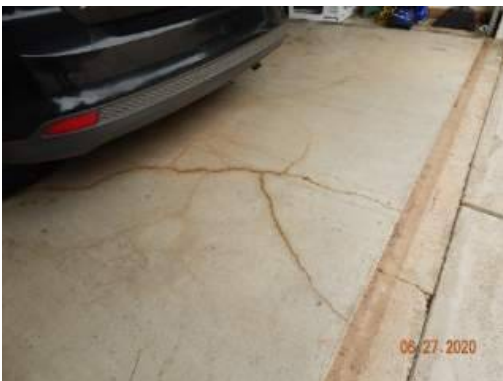
Photo 34-1

Minor cracks were found in the concrete slab floor. These are common and appeared to be only a cosmetic issue.

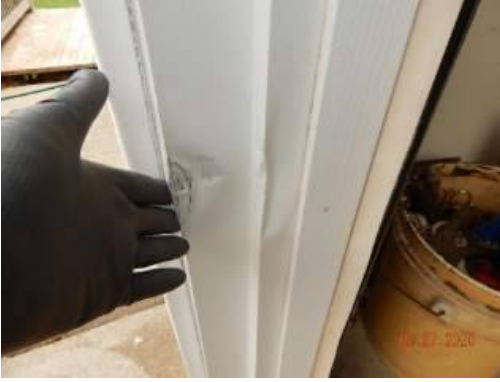
Photo 35-1

One or more exterior doors had minor damage and/or deterioration. Although serviceable, the client may wish to repair or replace such doors for appearances' sake.

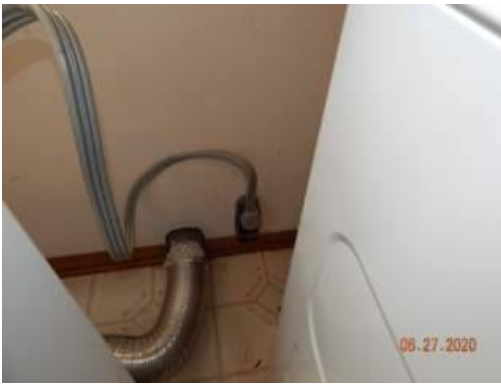
Photo 39-1

A 3-slot receptacle was installed for the clothes dryer. Most modern clothes dryers use both 120 and 240 volts (120 for timers and motors, and 240 for heating elements) and either require or are more safely installed with a 4-slot receptacle. With 3-conductor wiring, the ground wire rather than a neutral wire is used to carry the return current back for the 120 volt leg. The clothes dryer's metal frame can become energized if the neutral wire becomes loose at the receptacle or panel. While 3-wire clothes dryer circuits were allowed prior to 1996 and are commonly found, they are considered unsafe due to the risk of shock. Recommend that a qualified electrician convert this to a 4-wire circuit. Note that this may require installing a new circuit wire from the panel to the clothes dryer location.

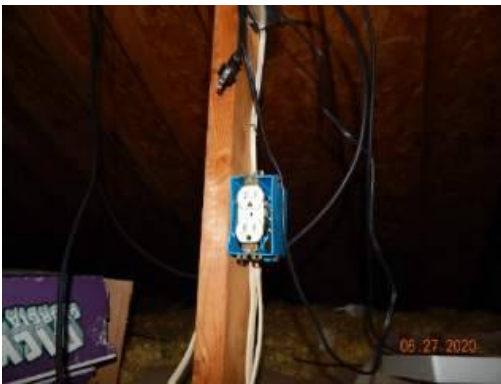
Photo 40-1

One or more cover plates for switches, receptacles or junction boxes were missing or broken. These plates are intended to contain fire and prevent electric shock from occurring due to exposed wires. Recommend that a qualified person install cover plates where necessary.

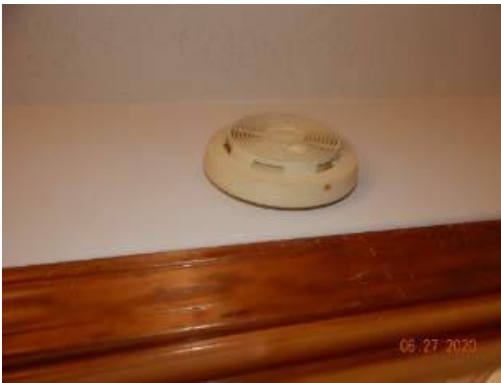
Photo 41-1

Based on the age of this structure and the appearance of existing smoke alarms, the alarms may have been installed more than 10 years ago. According to [National Fire Protection Association](https://www.nfpa.org), aging smoke alarms don't operate as efficiently and often are the source for nuisance alarms. Older smoke alarms are estimated to have a 30% probability of failure within the first 10 years. Newer smoke alarms do better, but should be replaced after 10 years. Unless you know that the smoke alarms are new, replacing them when moving into a new residence is also recommended by NFPA. For more information, visit: <https://www.reporthost.com/?SMKALRMLS>

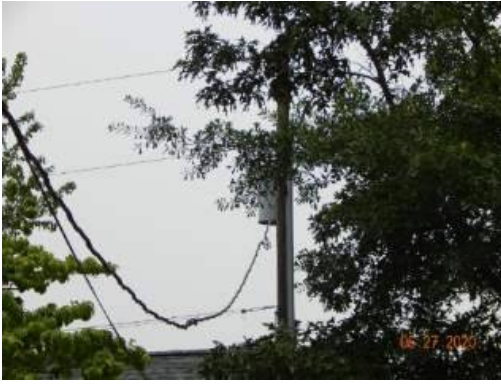
Photo 42-1

The service drop wires were in contact with trees or vegetation. This can result in damage to wiring insulation or broken wires during high winds. Recommend pruning trees or vegetation as necessary. The utility company may prune trees at no charge.

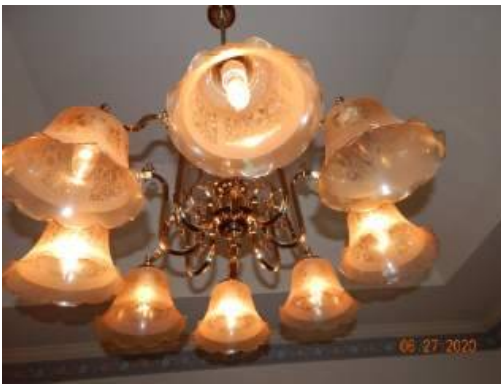
Photo 43-1

Bulbs in one or more light fixtures were missing or broken. These light fixtures couldn't be fully evaluated. If replacement bulbs are inoperable, then recommend that a qualified electrician evaluate and repair or replace light fixtures as necessary.

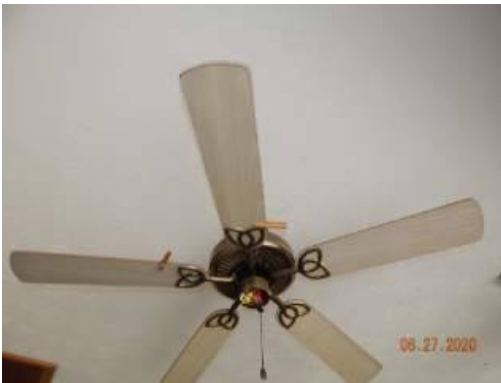
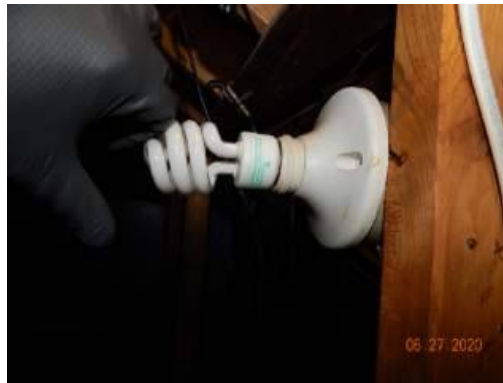
44) One or more light fixtures were inoperable (didn't turn on when nearby switches were operated). Recommend further evaluation by replacing bulbs and/or consulting with the property owner. If replacing bulbs doesn't work and/or no other switch(es) can be found, then recommend that a qualified electrician evaluate and repair or replace light fixtures as necessary.

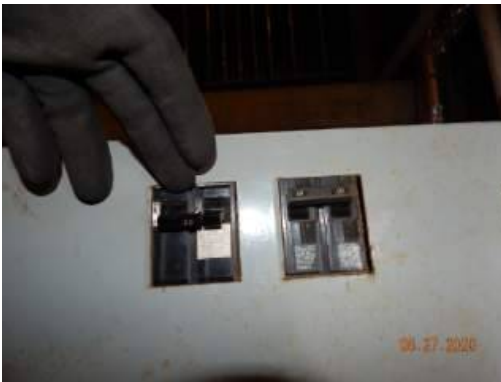
Photo 45-1

45) One or more circuit breakers in panel(s) #E were in the off position. Consult with the property owner to determine why breakers were tripped or off, and that a qualified electrician evaluate and repair if necessary. Note that the inspector does not operate circuit breakers.

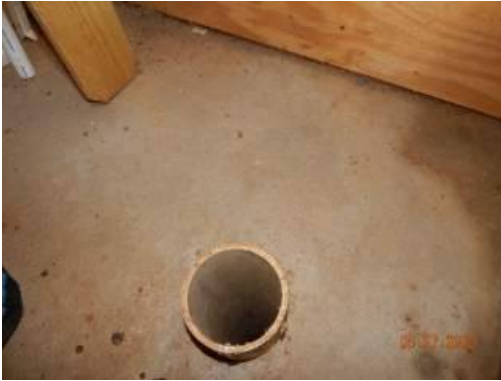
Photo 46-1

One or more waste line clean-out caps were missing, damaged or substandard. Leaks can occur or sewer gases can enter living spaces as a result. Recommend that a qualified plumber replace the cap(s) as necessary.

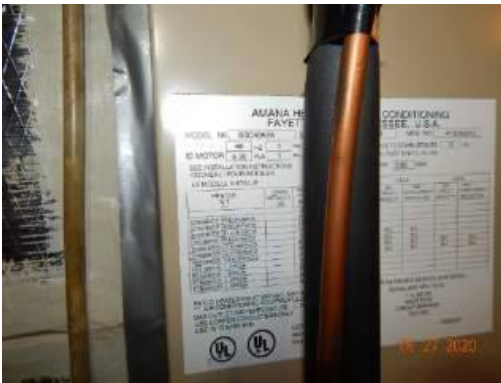
Photo 48-1

The estimated useful life for most forced air furnaces is 15-20 years. This furnace appeared to be at this age and/or its useful lifespan and may need replacing or significant repairs at any time. Recommend budgeting for a replacement in the near future.

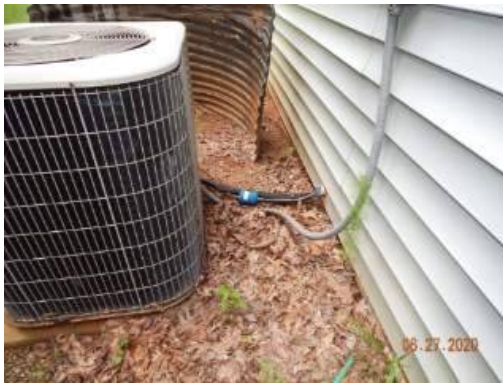
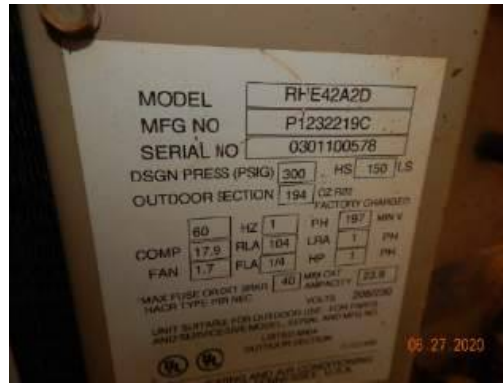
The estimated useful life for most heat pumps and air conditioning condensing units is 10-15 years. This unit appeared to be beyond this age and/or its useful lifespan and may need replacing or significant repairs at any time. Recommend budgeting for a replacement in the near future.

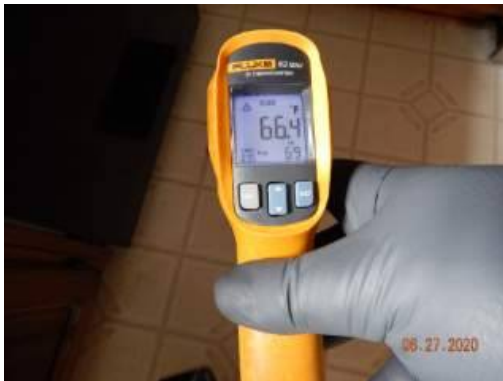
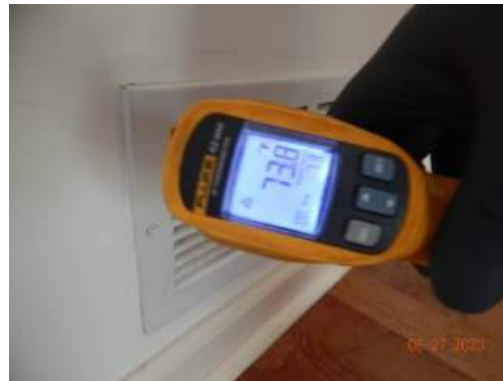
50) Supply air from the air conditioning or heat pump cooling system was not cool enough. It should be 14-20 degrees Fahrenheit cooler than at the return duct(s) or current room temperature. This may be caused by refrigerant loss, dirty coils, a failing compressor, an over-sized fan, or a deficient return-air system. Recommend that a qualified HVAC contractor evaluate and repair as necessary.

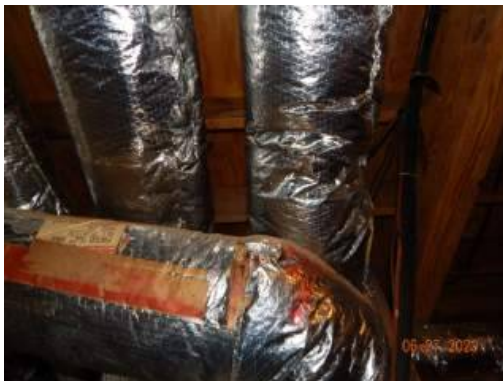
Photo 51-1

51) One or more heating or cooling ducts in an unconditioned space (e.g. crawl space, attic or basement) were not insulated, or the insulation was damaged or deteriorated. This can result in reduced energy efficiency, moisture inside heating ducts, and/or "sweating" on cooling ducts. Recommend that a qualified person repair per standard building practices. For example, by wrapping ducts in insulation with an R-value of R-8.

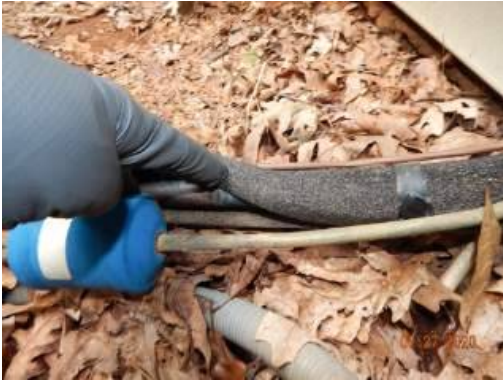
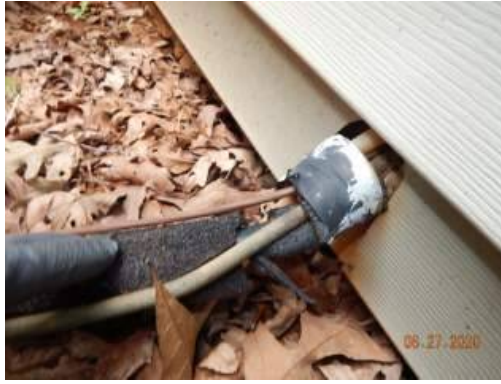
52) Insulation on the heat pump or air conditioning condensing unit's refrigerant lines was deteriorated or missing in some areas. This may result in reduced efficiency and increased energy costs. Recommend that a qualified person replace or install insulation as necessary.

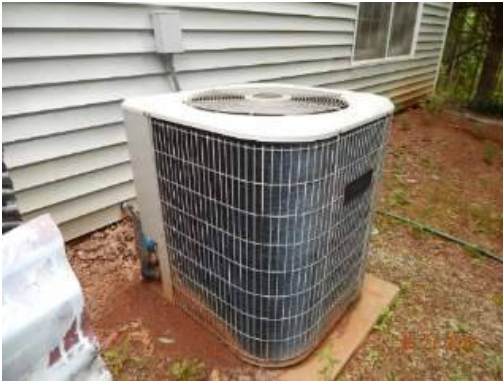
Photo 54-1

54) 🛠️ The cooling fins at the heat pump or air conditioning condensing unit were dirty. Energy efficiency can be reduced as a result. Recommend that a qualified person clean fins as necessary.

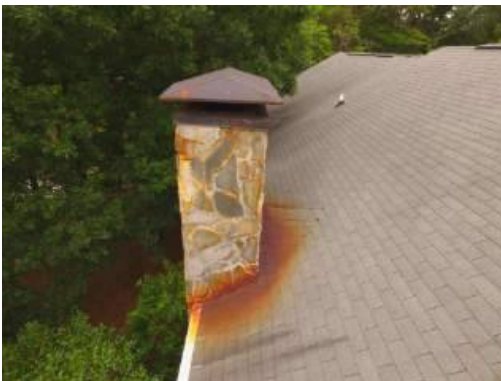
Photo 56-1

One or more metal flue caps for B-vent or L-vent flues were corroded. Such metal flues should terminate with a bird-proof and weatherproof cap. Recommend that a qualified person repair per standard building practices

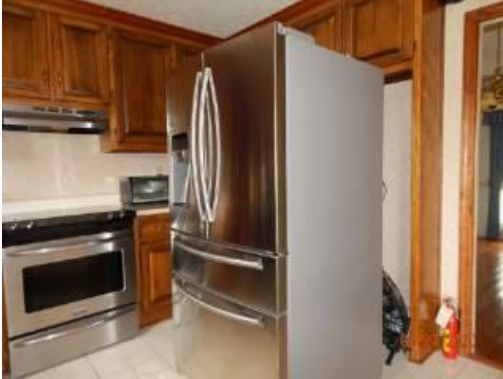
Photo 58-1

The refrigerator was Being serviced. Recommend that a qualified person repair as necessary. The refrigerator may need replacing.

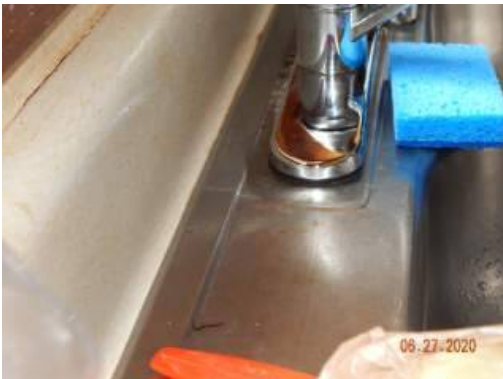
Photo 59-1

Gaps, no caulk, or substandard caulking were found around the sink. Water may penetrate these areas and cause damage. Recommend that a qualified person repair as necessary. For example, by installing caulk.

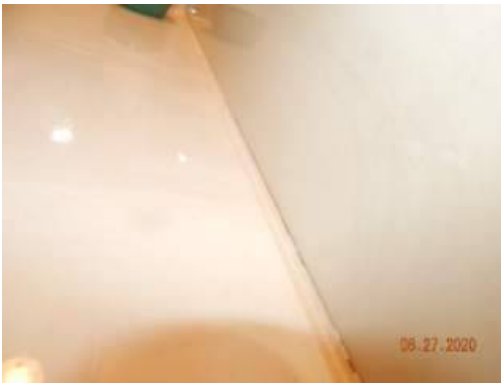
Photo 62-1

Gaps, no caulk, or substandard caulking were found between countertops and backsplashes at location(s) #B. Water can penetrate these areas and cause damage. Recommend that a qualified person repair as necessary. For example, by installing or replacing caulk.

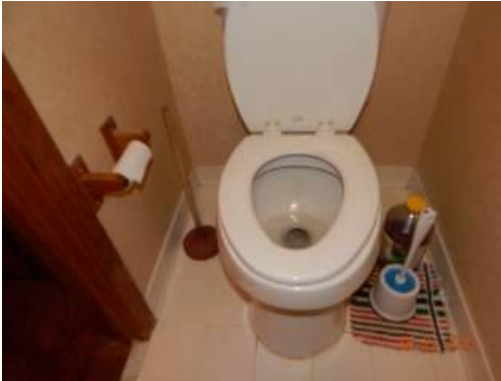
Photo 63-1

Caulk around the base of the toilet at location(s) #B and C was missing, substandard and/or deteriorated. Modern standards require caulk to be installed around the entire toilet base where it meets the floor for sanitary reasons. Without it, soiled water can soak into flooring and sub-floor materials if the toilet overflows. Condensation from the toilet can also soak into the flooring. Recommend that a qualified person caulk around toilet bases per standard building practices.

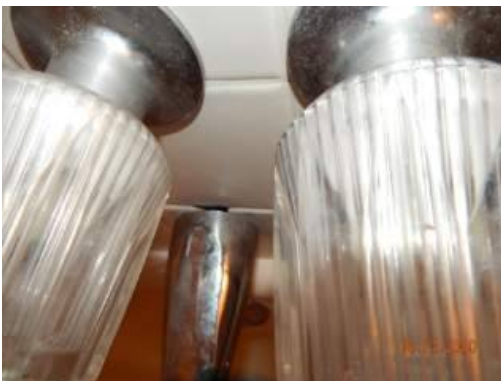
Photo 64-1

Caulk was missing around the base of the bathtub spout, or there was a gap behind it, at location(s) #B. Water may enter the wall structure behind the bathtub. Recommend that a qualified person repair as necessary to eliminate the gap. For example, by installing or replacing caulk if the gap is small enough. For larger gaps, a shorter spout nipple or an escutcheon plate can be installed.

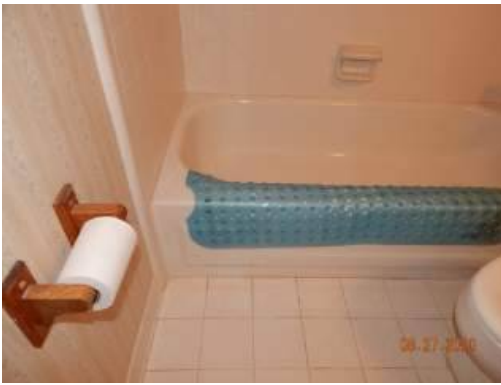
Photo 65-1

Gaps, no caulk, or substandard caulking were found between the bathtub and the floor and/or walls at location(s) #B. Water may penetrate these areas and cause damage. Recommend that a qualified person re-caulk or install caulking as necessary.

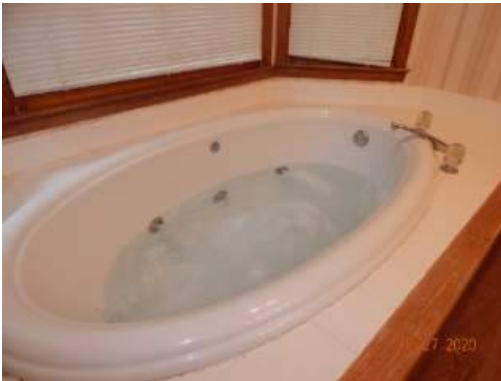
Photo 66-1

66) 🛠️ The bathtub drain stopper mechanism at location(s) #C was inoperable. Recommend that a qualified person repair or replace as necessary.

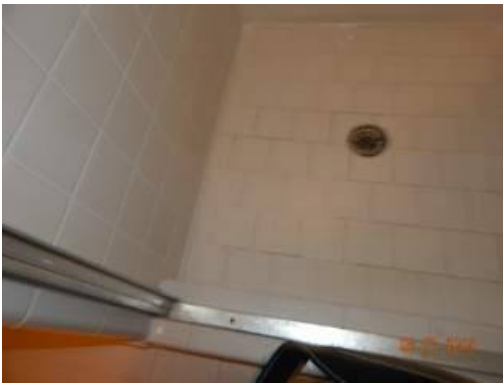
Photo 67-1

67) 🛠️ Tile, caulk and/or grout in the shower enclosure at location(s) #B and C were deteriorated (e.g. loose or cracked tiles, missing grout) or substandard. Water may leak through gaps and damage the wall or floor structure as a result. Recommend that a qualified contractor repair as necessary. Note that the condition of the structure behind and below the shower enclosure is unknown due to it being concealed.

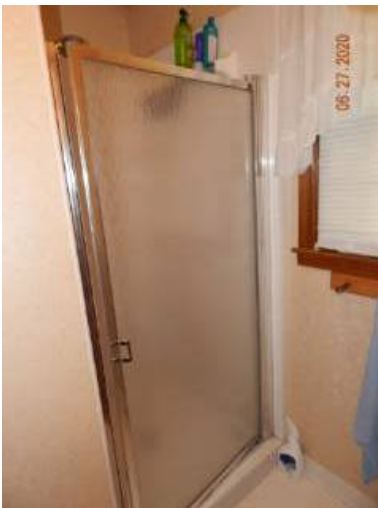
Photo 68-1

68) 🛠️ The shower door at location(s) #C wouldn't latch or close fully. Water can leak out of the enclosure during showers. Recommend that a qualified person repair as necessary.

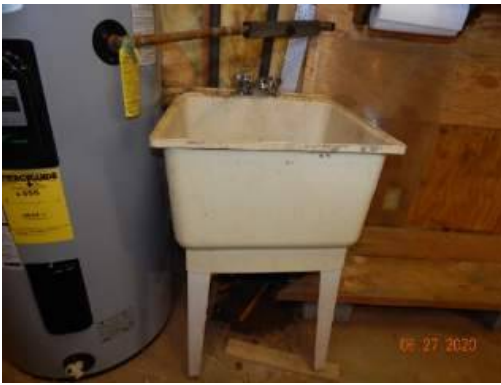
Photo 69-1

69) 🛠️ The laundry sink drain was leaking. A qualified person should repair as necessary.

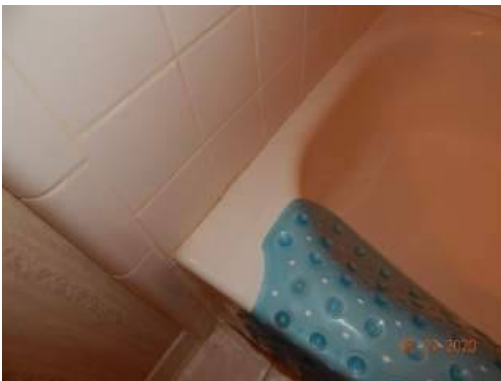
Photo 70-1

70) 🛠️ Recommend cleaning and sealing the grout in flooring at location(s) #B now and in the future as necessary to prevent staining and to improve waterproofing.

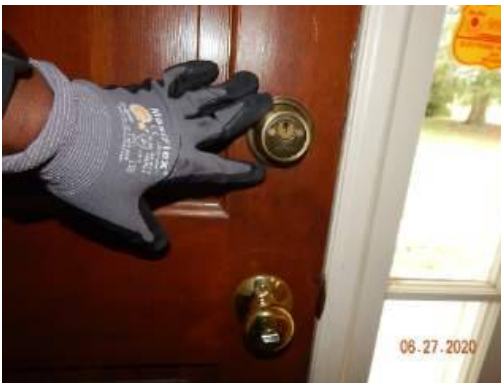
Photo 72-1

One or more exterior doors had double-cylinder deadbolts installed, where a key is required to open them from both sides. This can be a safety hazard in the event of an emergency because egress can be obstructed or delayed. Recommend replacing double-cylinder deadbolts with single-cylinder deadbolts where a handle is installed on the interior side.
