3rd EYE HOME INSPECTION, LLC Inspection Report

Client(s): **New Construction Sample Report**

Property address: **111 Sample Report Ln 2
Jonesboro, GA 30000**

Inspection date: **Tuesday, January 19, 2021**

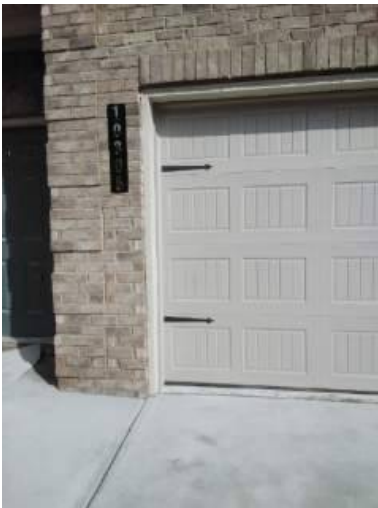
Photo 2-1

Caulk was missing in some areas. For example, at siding butt joints and/or at wall penetrations. Recommend that a qualified person renew or install caulk as necessary. Where gaps are wider than 1/4 inch, an appropriate material other than caulk should be used. For more information, visit:

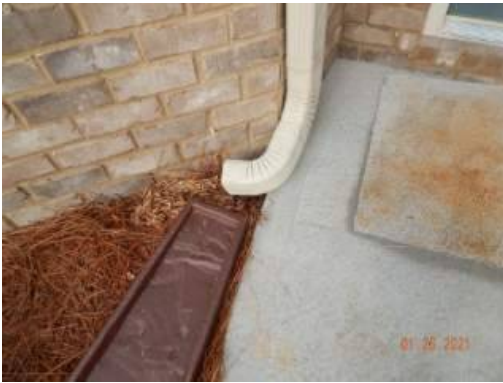
Photo 3-1

Extensions such as splash blocks or drain pipes for one or more downspouts were poorly sloped and/or misaligned. Water can accumulate around the building foundation or inside crawl spaces or basements as a result. Recommend that a qualified person install, replace or repair extensions as necessary so rainwater drains away from the structure.

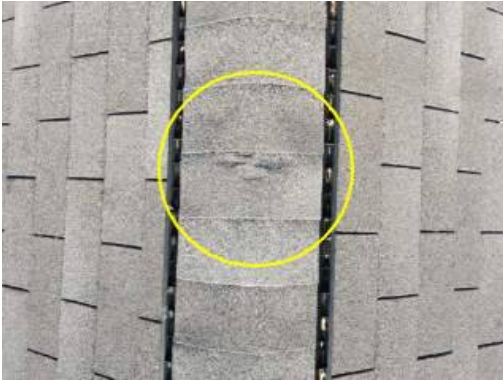
Photo 4-1

Some composition shingles were Minor impressions. Leaks can occur as a result. This is a conducive condition for wood-destroying organisms. Recommend that a qualified contractor repair as necessary. For example, by replacing shingles.

On the ridge a few shingles appeared to have showed signs of impressions

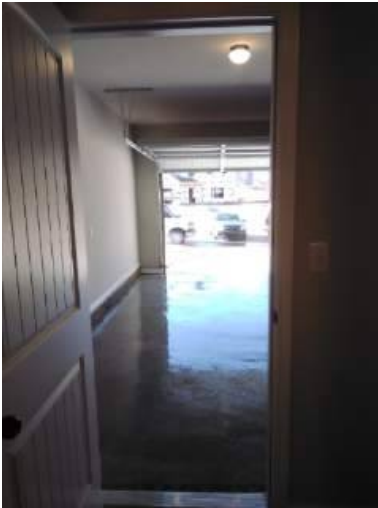
Photo 5-1

Weatherstripping around or at the base of the door between the garage and the house was missing. House to garage doors should prevent fire and fumes from spreading from the garage to the house. Weatherstripping should form a seal around this door. This is a potential safety hazard. Recommend that a qualified person replace or install weatherstripping as necessary.

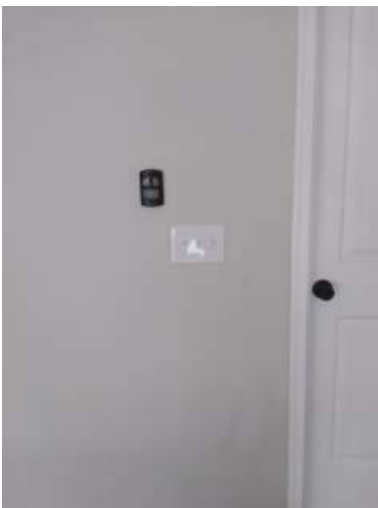
Photo 6-1

The wall-mounted control for one or more automatic garage vehicle door openers was less than 5 feet off the floor, or within reach of children. This is a safety hazard. Children should not be able to operate automatic garage vehicle door openers. A qualified person should relocate controls for door openers so they are at least 5 feet above floors and/or out of reach of children. For more information on garage door safety issues, visit:

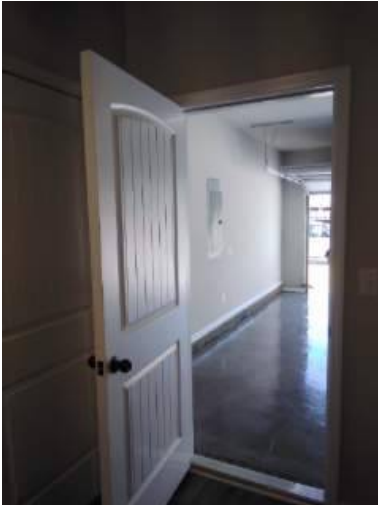
Photo 7-1

The self-closing device on the door between the garage and the house didn't close and latch the door. These devices are installed to keep the door closed to prevent possible fire and fumes from the garage from spreading to the house. Recommend that a qualified person repair as necessary.

**Recommend having a spring loaded hinge installed

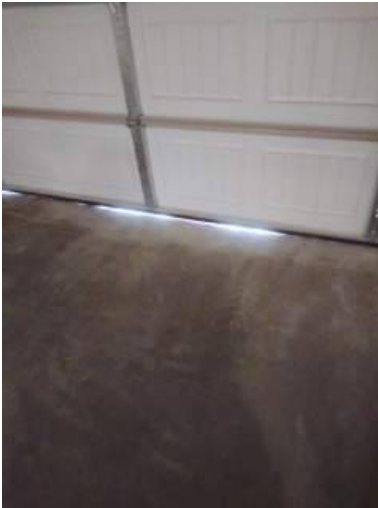
Photo 8-1

Significant gaps were found below or around one or more garage vehicle doors. Vermin and insects can enter the garage as a result. Recommend that a qualified person repair as necessary to eliminate or minimize gaps.

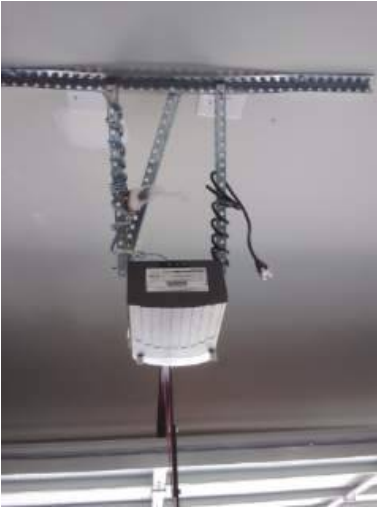
Photo 9-1

One or more automatic door openers were not plugged in or had no power. The inspector was unable to fully evaluate the automatic opener(s).

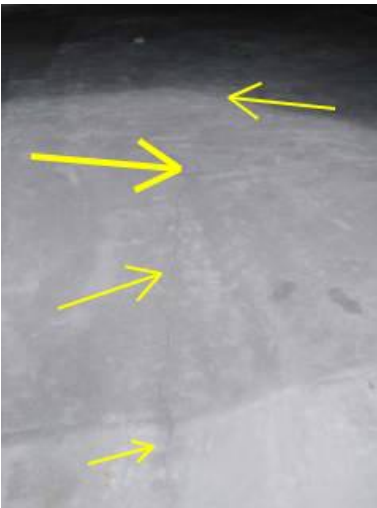
Photo 10-1

10) **i** Minor cracks were found in the concrete slab floor. These are common and appeared to be only a cosmetic issue.

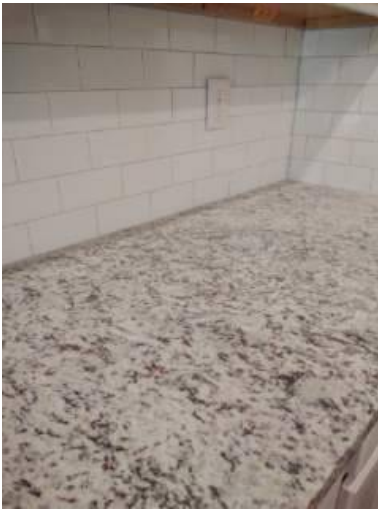
Photo 11-1

One or more electric receptacles and/or the boxes in which they were installed were loose and/or not securely anchored. Wire conductors can be damaged due to repeated movement and/or tension on wires, or insulation can be damaged. This is a shock and fire hazard. Recommend that a qualified electrician repair as necessary.

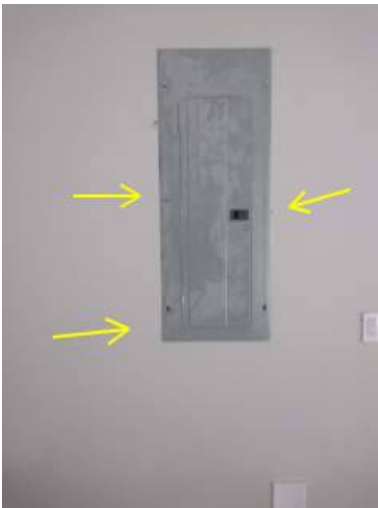
Photo 12-1

One or more screws that attach the cover or dead front to panel(s) #A were missing or not installed. Recommend installing screws where missing so the cover or dead front is secure. Only screws with blunt tips approved for this purpose should be installed, so wiring inside the panel is not damaged. Because energized wires may be located directly behind screw holes, the client should consider having a qualified electrician replace missing screws.

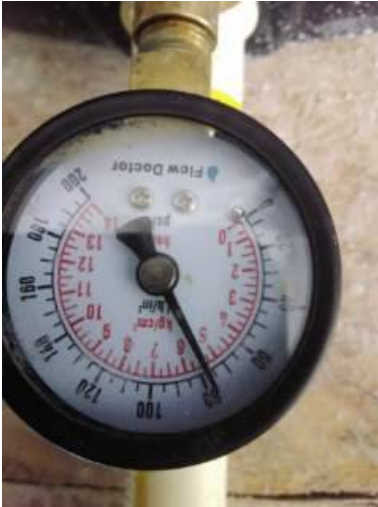
Photo 13-1

The water supply pressure was greater than 80 pounds per square inch (PSI). Pressures above 80 PSI may void warranties for some appliances such as water heaters or washing machines. Flexible supply lines to washing machines are likely to burst with higher pressures. 40-80 PSI is considered the normal range for water pressure in a home, and most plumbers recommend 50-60 PSI. Typically, the pressure cannot be regulated at the water meter. Recommend that a qualified plumber evaluate and make modifications to reduce the pressure to below 80 PSI. Installing a pressure reducing valve on the main service pipe is a common solution to this problem. If one exists, then it should be adjusted, repaired or replaced as necessary to maintain lower pressures. Note that installing a pressure reducing valve creates a "closed system," which may require installing an expansion tank at the water heater if one is not already installed.

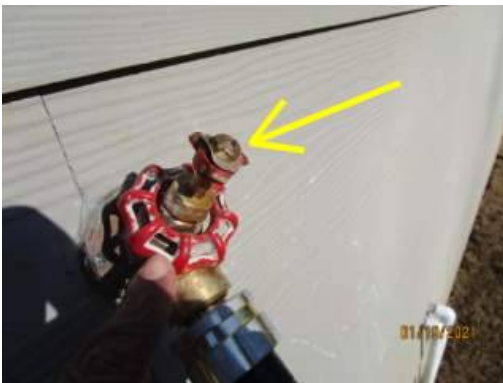
Photo 14-1

One or more hose bib handles were broken. Recommend that a qualified person replace handles or make repairs as necessary.

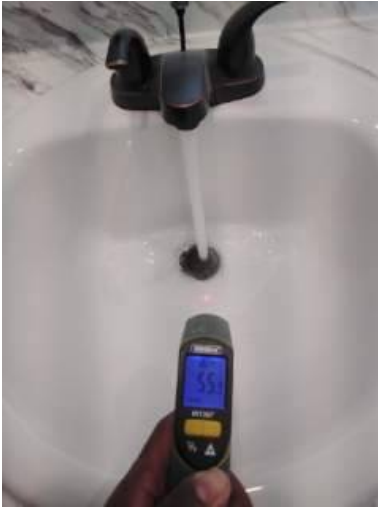
Photo 15-1

The hot water temperature was significantly lower than the standard temperature range of 110-120 degrees Fahrenheit. The thermostat should be adjusted to a higher setting. If the water temperature doesn't reach 120 degrees, then recommend that a qualified plumber evaluate and repair or replace the water heater as necessary.

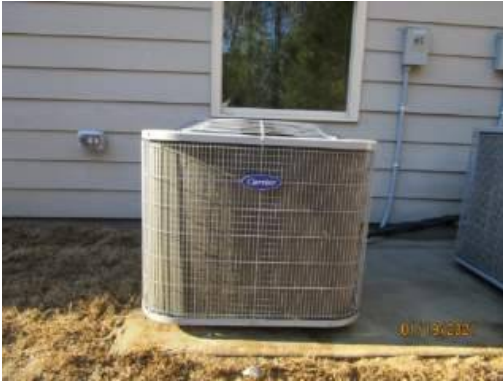
Photo 16-1

The cooling fins at the heat pump or air conditioning condensing unit showed signs of minor damaged. Energy efficiency can be reduced as a result. Recommend that a qualified person repair fins as necessary.

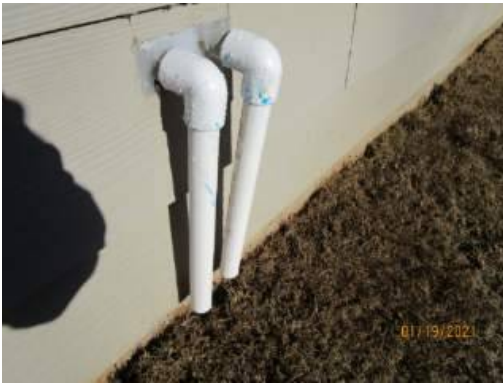
Photo 17-1

The air handler's primary condensate drain line was routed so it drains close the foundation. Significant amounts of water can be produced by this system and can cause water infiltration. In extreme cases the wet soil may not adequately support the foundation. Recommend repairing as necessary so condensate water drains well away from the foundation. For example, by installing a splash block.

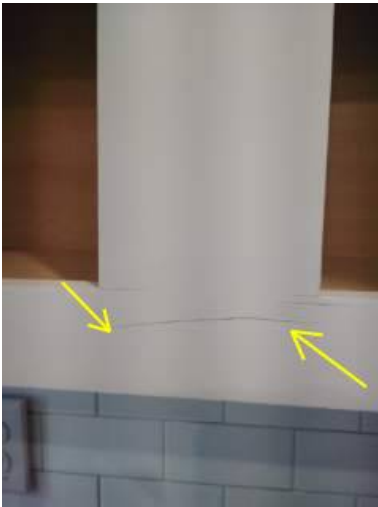
Photo 19-1

One or more cabinets, drawers and/or cabinet doors were damaged, loose and/or Doors don't close flush. Recommend that a qualified person repair or replace as necessary.

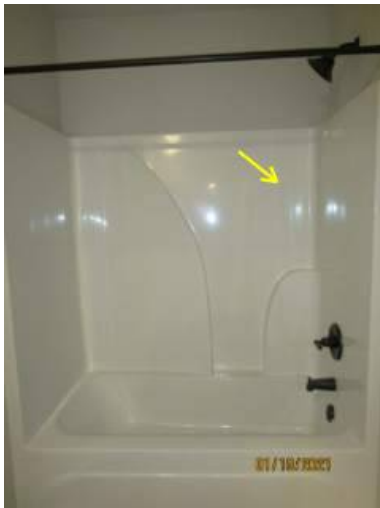
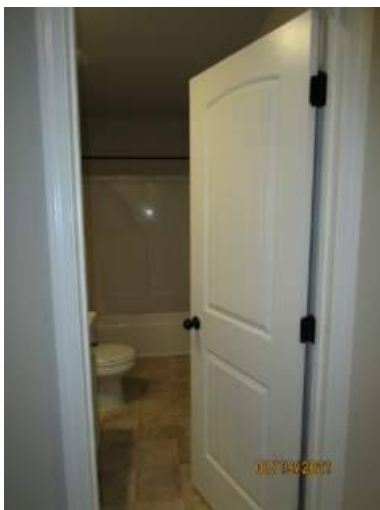
The bathtub at location(s) #A, and #D was worn, blemished or deteriorated.

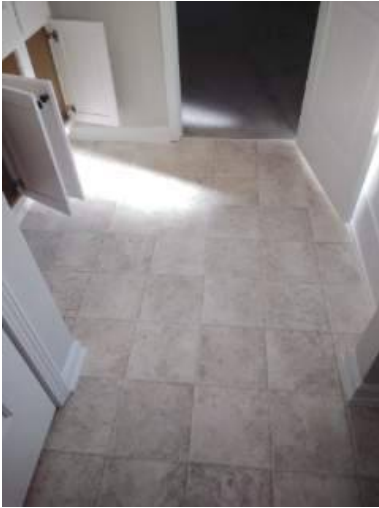
Photo 21-1

Vinyl flooring with seams was installed in the bathroom at location(s) #B, C and D. Spilled water can penetrate seams and damage the sub-floor. Recommend that a qualified contractor install continuous waterproof flooring in wet areas such as bathrooms.

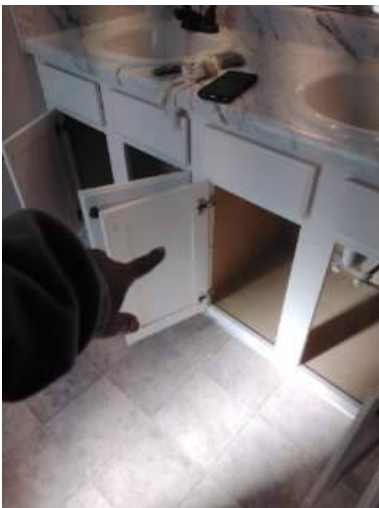
Photo 22-1

One or more cabinets, drawers and/or cabinet doors at location(s) #A, B and D were loose. Recommend that a qualified person repair or replace as necessary.

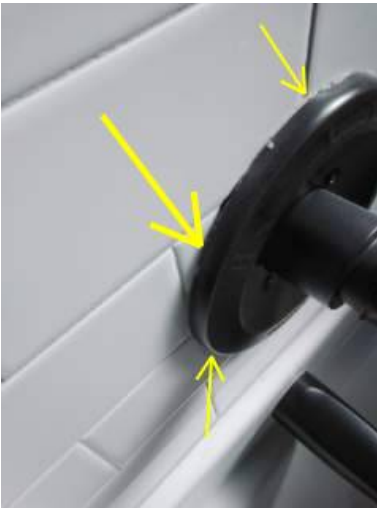
**Photo 23-1**

Caulk was missing around the base of the bathtub spout, or there was a gap behind it, at location(s) #B. Water may enter the wall structure behind the bathtub. Recommend that a qualified person repair as necessary to eliminate the gap. For example, by installing or replacing caulk if the gap is small enough. For larger gaps, a shorter spout nipple or an escutcheon plate can be installed.

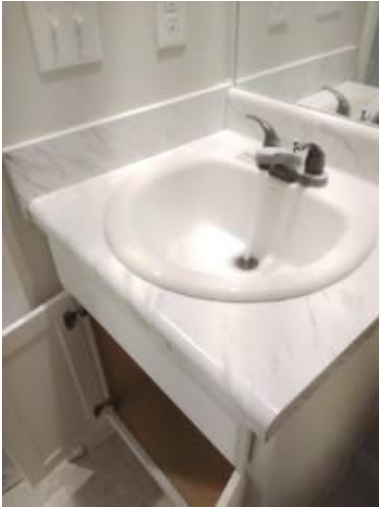
Photo 24-1

Gaps, no caulk, or substandard caulking were found between countertops and backsplashes and/or around the sink at location(s) #A, B and D. Water can penetrate these areas and cause damage. Recommend that a qualified person repair as necessary. For example, by installing or replacing caulk.

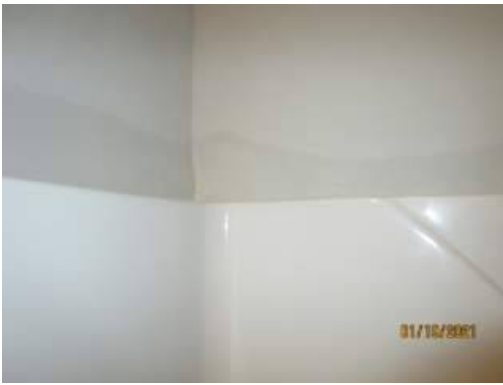
Photo 25-1

Gaps, no caulk, or substandard caulking were found between the shower enclosure and the walls at location(s) #A and D. Water can penetrate these areas and cause damage. Recommend that a qualified person re-caulk or install caulking as necessary.

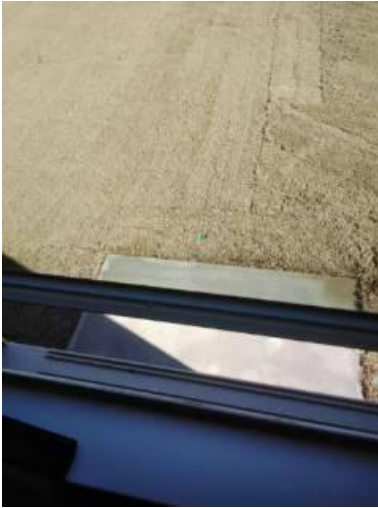
Photo 26-1

Based on height of windows from the ground and planned occupancy (children in home), recommend that the client consider installing window guards for child safety. For more information, visit:

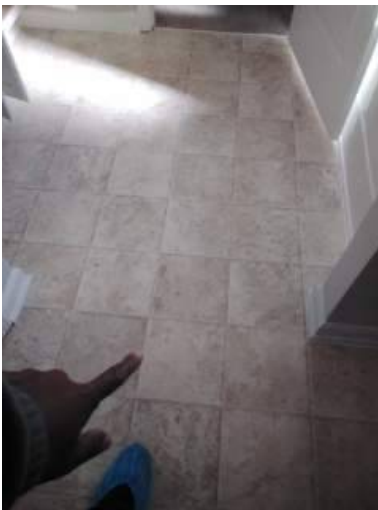
Photo 27-1

Floors in one or more areas were not level. This can be caused by foundation settlement or movement of the foundation, posts and/or beams. Significant repairs may be needed to make floors level. Recommend that a qualified contractor and/or engineer evaluate further. Repairs should be performed by a qualified contractor.

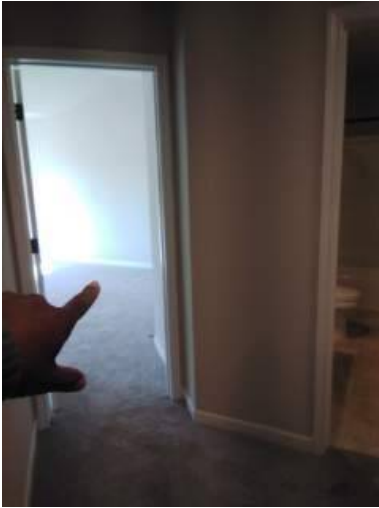
One or more doors dragged on the carpet below and were difficult to open and close. Recommend that a qualified person repair as necessary. For example, by trimming bottoms of doors.

Photo 28-1 NE Bedroom closet

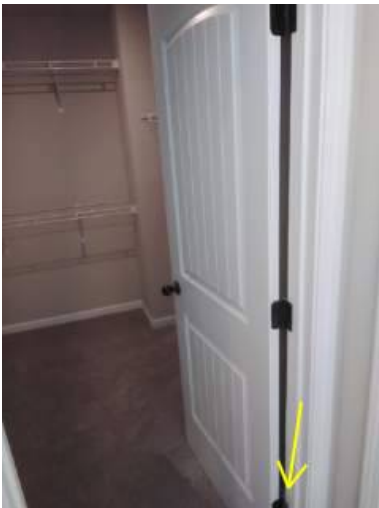
Photo 29-1

Some interior door hardware (locksets and/or hinges) were loose. Recommend that a qualified person repair or replace as necessary.

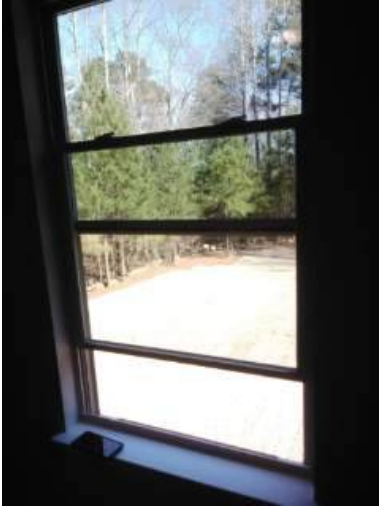
Photo 30-1

One or more windows that were designed to open and close were difficult to open and close. Recommend that a qualified person repair windows as

necessary so they open and close easily.

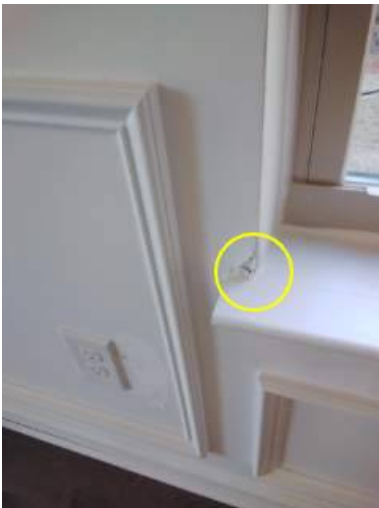
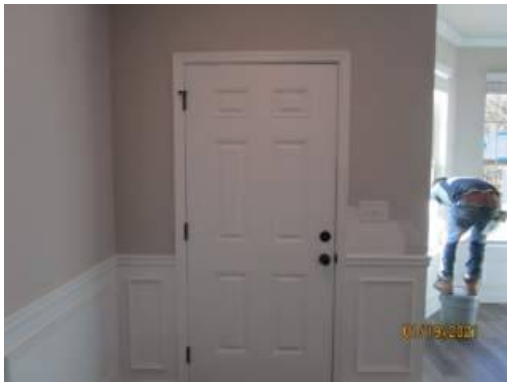
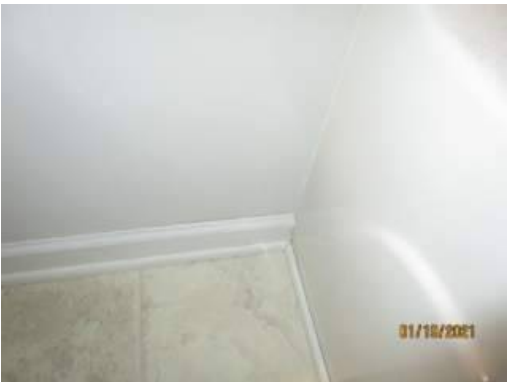
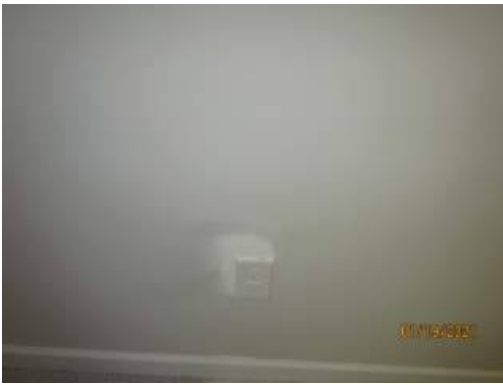
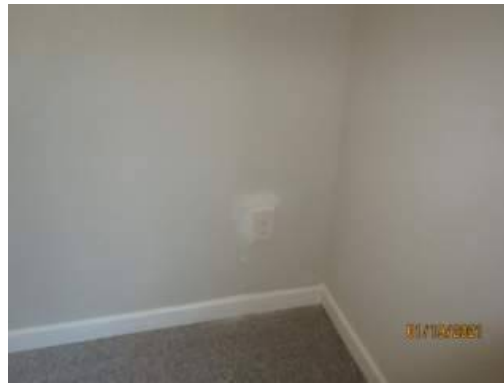
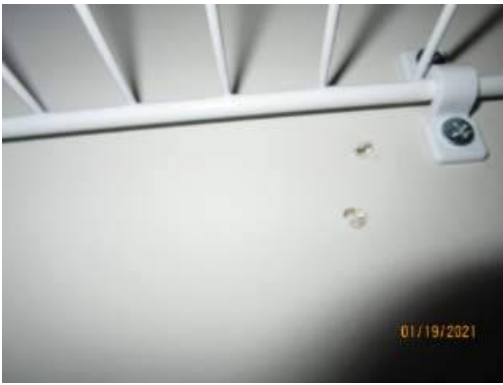
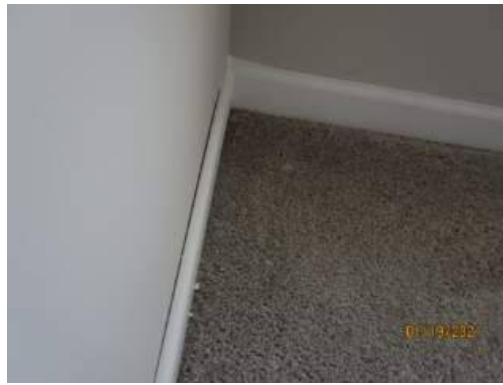
One or more walls and/or ceilings were damaged and/or had substandard repairs. Recommend that a qualified person repair as necessary.

We observed many walls and ceilings at the time of this inspection.

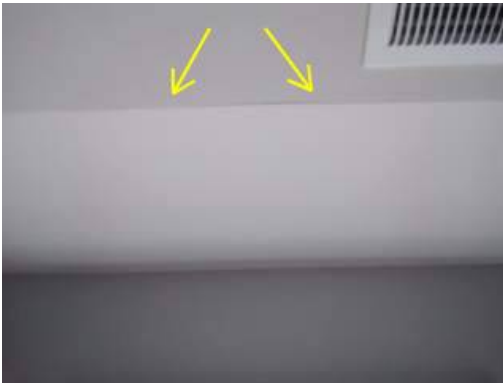
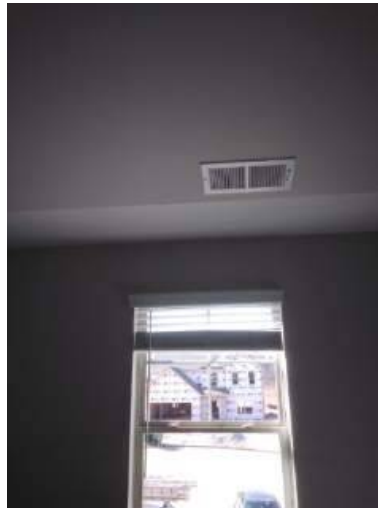
32) 🛠️ Minor cracks, nail pops and/or blemishes were found in walls and/or ceilings in one or more areas. Cracks and nail pops are common, are often caused by lumber shrinkage or minor settlement, and can be more or less noticeable depending on changes in humidity. They did not appear to be a structural concern, but the client may wish to repair these for aesthetic reasons. For recurring cracks, consider using an elastic crack covering product: <https://www.reporhost.com/?ECC>

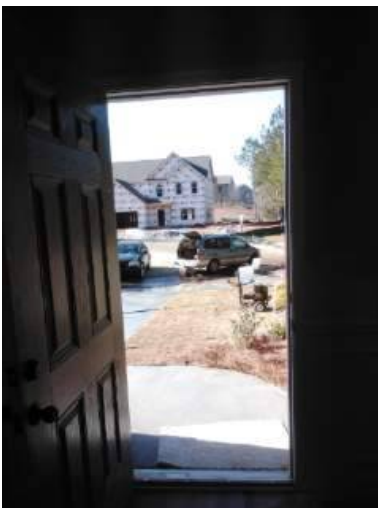
Photo 33-1

33) 🛠️ Weatherstripping around one or more exterior doors was missing. Water may enter the building, or energy efficiency may be reduced. Recommend that a qualified person repair or replace weatherstripping as necessary.

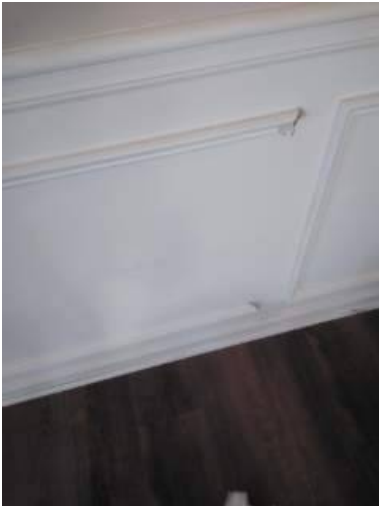
Photo 34-1

Trim was loose, missing and/or damaged in one or more areas. Recommend that a qualified person repair as necessary.

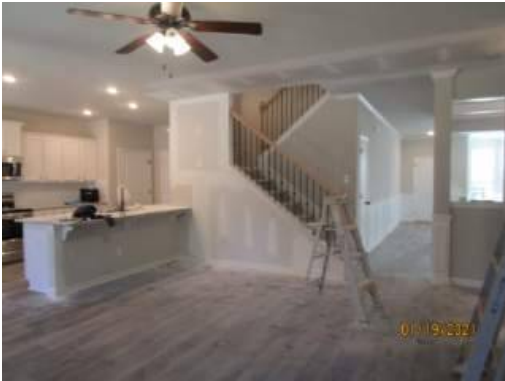
Photo 35-1

We observed one or more treads flexed under weight/ and or make a squeaky sound at the time of this inspection. Recommend having a qualified person evaluate further and make the necessary repairs. The 3rd or 4th tread from the second (Top) landing of stairs.

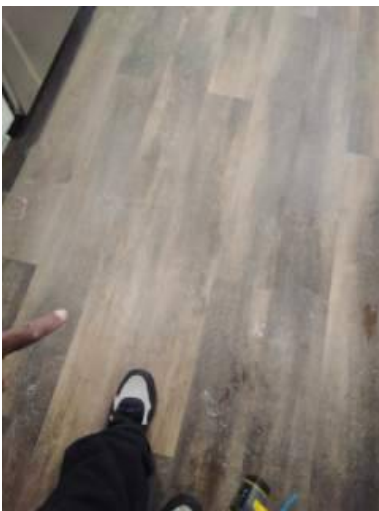
Photo 36-1

Vinyl, linoleum or marmoleum flooring in one or more areas was loose and/or Loose. If in a wet area, water can damage the sub-floor as a result. Recommend that a qualified contractor replace or repair flooring as necessary.
