**3rd EYE HOME INSPECTION, LLC Inspection Report**

Client(s): **SAMPLE REPORT 1**

Property address: **1212 Mocking Bird Ln, GA**

Inspection date: **Tuesday, June 2, 2020**

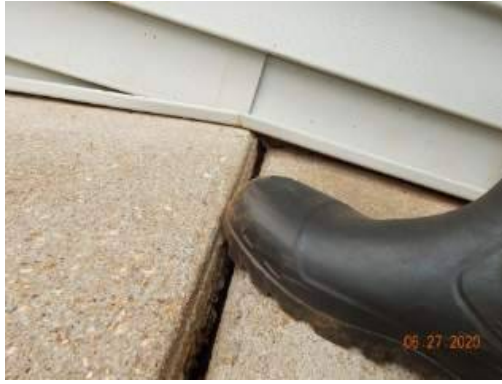
Photo 2-2

Cracks, holes, settlement, heaving and/or deterioration resulting in trip hazards were found in the sidewalks or patios. For safety reasons, recommend that a qualified contractor repair as necessary to eliminate trip hazards.

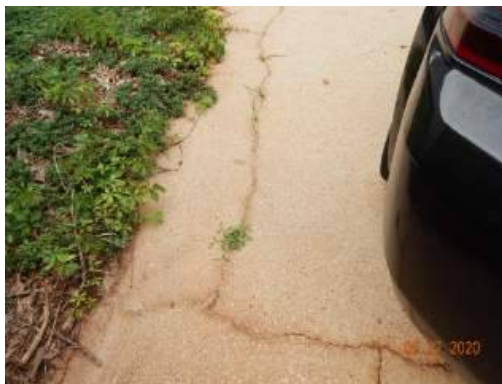
Photo 4-2

Cracks, holes, settlement, heaving and/or deterioration were found in the driveway. Recommend that qualified contractor repair as necessary.

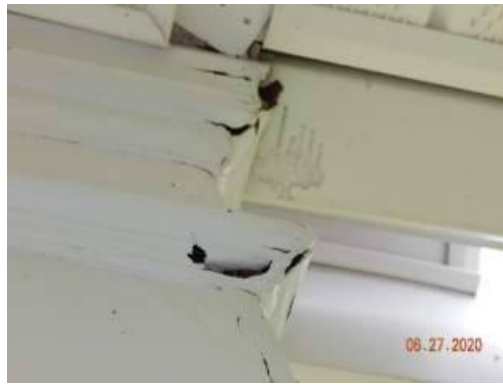
Photo 5-2

5) 🪛 Fungal rot was found in support posts at one or more structures covering decks, patios and/or porches. Recommend that a qualified person repair as necessary. All rotten wood should be replaced.

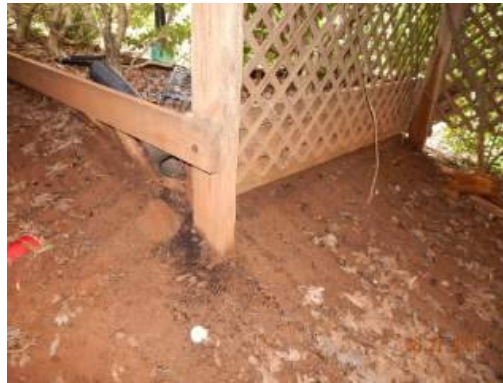
Photo 6-2

6) 🚧 Soil was in contact with one or more wooden deck, porch or balcony support posts. This is a conducive condition for wood destroying organisms. Even if posts are made of treated wood, the cut ends below soil may not have been field treated. Recommend grading soil or repairing as necessary to prevent wood-soil contact.

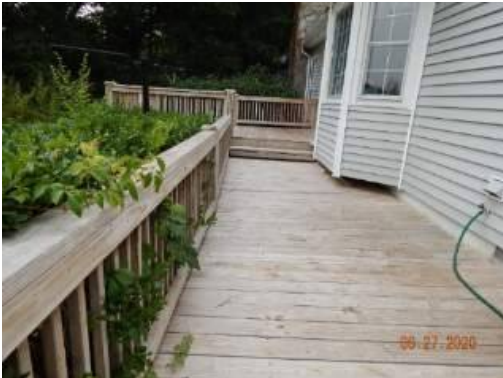
Photo 7-1

Resurfacing paint on one or more decks, porches or balconies was peeling and failing. This type of coating is similar to extremely thick paint and is designed to mask wood and fill large cracks or voids. Such products include Behr Deckover, Olympic Rescue-It, Rust-Oleum Deck Restore, Cabot Deck Correct and Pittsburgh Revitalize. Peeling can be an issue for any film-forming coating, but many reports of peeling have been made regarding these thick resurfacing paints. Once this type of coating begins to fail, repairing the coating may be difficult, or not work. Removal of this coating in order to apply a different finish can be very difficult. Recommend consulting with a qualified painting contractor to determine what repairs or maintenance are needed. For more information, visit:

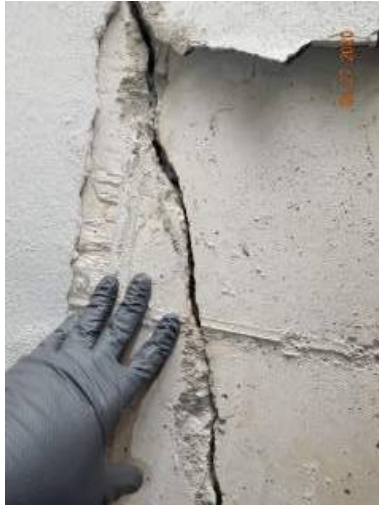
Photo 9-2

9) Major cracks (more than 3/4-inch wide) and/or leaning was found in the foundation. These appear to be a structural concern and may indicate that settlement is ongoing. Recommend hiring qualified contractors and/or engineers as necessary for further evaluation. Such contractors may include:

- Foundation repair contractors who may prescribe repairs, and will give cost estimates for such repairs
- Masonry contractors who repair and/or replace brick veneer
- Geotechnical engineers who attempt to determine if settlement is ongoing, and the cause of the settlement
- Structural engineers who determine if repairs are necessary, and prescribe those repairs

Repairs should be made by a qualified contractor.

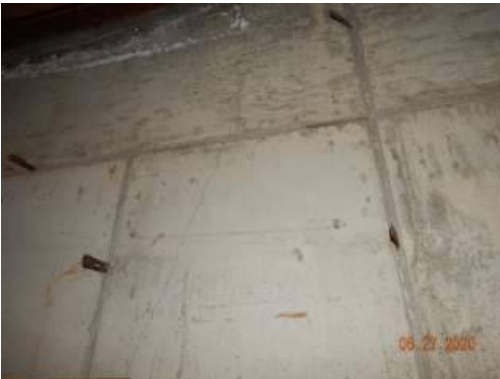
**Photo 11-1**

Moderate cracks (1/8 inch - 3/4 inch) and/or leaning were found in the foundation. This may be a structural concern or an indication that settlement is ongoing. The client should consider hiring qualified contractors and/or engineers as necessary for further evaluation. Such contractors may include:

- Foundation repair contractors who may prescribe repairs, and will give cost estimates for such repairs
- Masonry contractors who repair and/or replace brick veneer
- Geotechnical engineers who attempt to determine if settlement is ongoing, and the cause of the settlement
- Structural engineers who determine if repairs are necessary, and prescribe those repairs

At a minimum, recommend sealing cracks to prevent water infiltration. Numerous products exist to seal such cracks including hydraulic cement, resilient caulks and epoxy sealants.

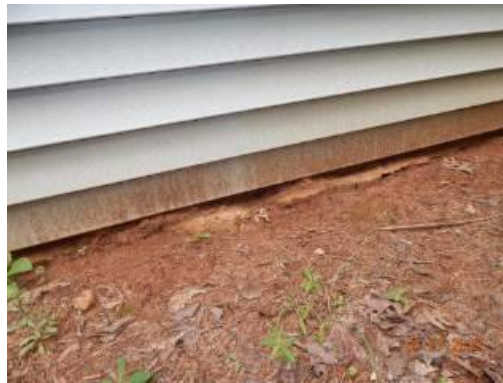
**Photo 12-2**

Soil was in contact with or less than 6 inches from siding or trim. Regardless of what material is used for siding, it should not be in contact with the soil. If made of wood, siding or trim will eventually rot. For other materials, ground or surface water can infiltrate siding or trim and cause damage to the wall structure. Wood-destroying insects are likely to infest and damage the wall structure. This is a conducive condition for wood-destroying organisms. Recommend grading or removing soil as necessary to maintain a 6-inch clearance. Note that damage from fungal rot and/or insects may be found when soil is removed, and repairs may be necessary.

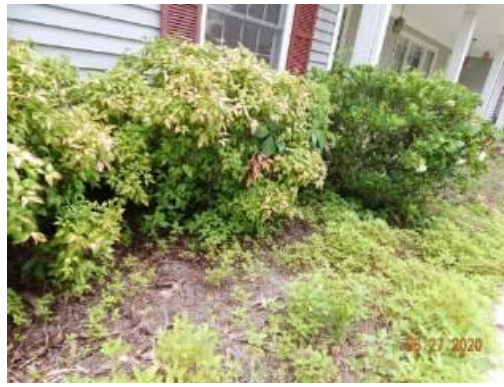
Photo 13-2

Vegetation such as trees, shrubs and/or vines was in contact with or close to the building exterior. Vegetation can serve as a pathway for wood-destroying insects and can retain moisture against the exterior after it rains. This is a conducive condition for wood-destroying organisms. Recommend pruning, moving or removing vegetation as necessary to maintain at least 6 inches of space between it and the building exterior. A 1-foot clearance is better.

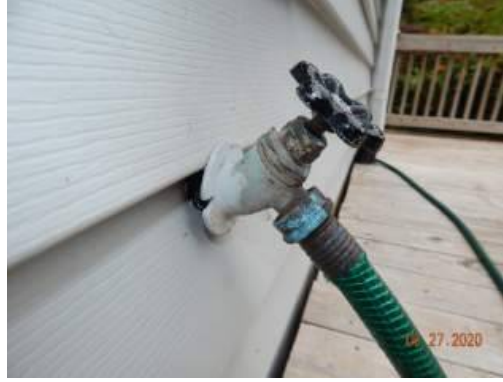
Photo 14-2

14) 🛠️Caulk was missing in some areas. For example, at siding-trim junctions and/or at wall penetrations. Recommend that a qualified person renew or install caulk as necessary. Where gaps are wider than 1/4 inch, an appropriate material other than caulk should be used. For more information, visit: <https://www.reporthost.com/?CAULK>

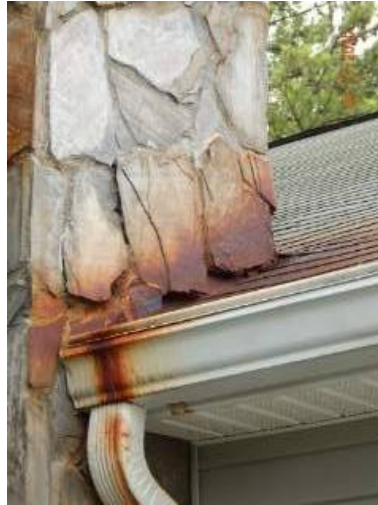
Photo 18-2

Flashings at the base of one or more chimneys were corroded. Leaks can occur as a result. This is a conducive condition for wood-destroying organisms. Recommend that a qualified contractor evaluate and repair as necessary.

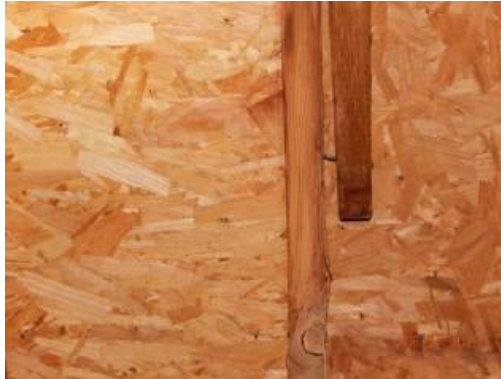
Photo 19-2

Observed one or more collar ties appeared to be disconnected from the rafter at the time of the inspection. Recommend having a qualified professional evaluate further and make any necessary repairs.

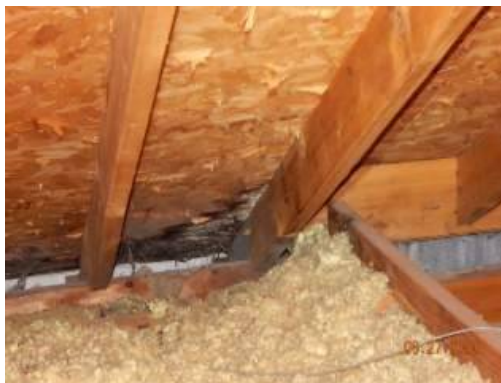
Photo 20-2

Fungal rot or significant water damage was found at one or more roof areas at edges of roof sheathing and/or fascia boards. Recommend that a qualified contractor repair as necessary. For example, by replacing all rotten wood, priming and painting new wood and installing flashing.

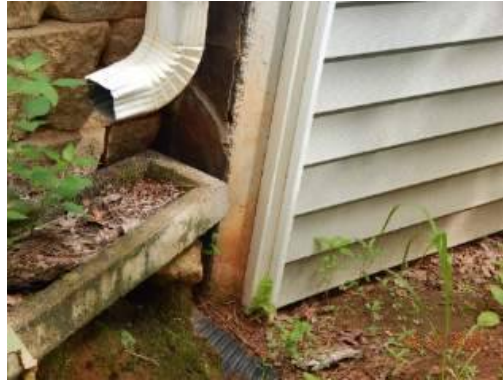
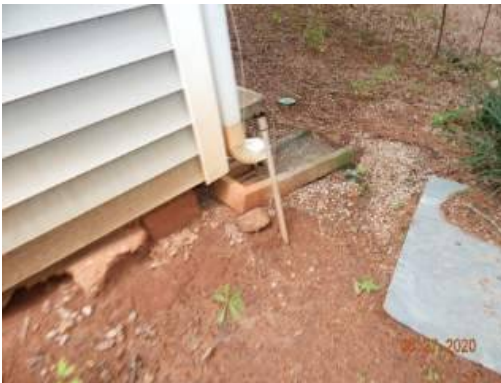
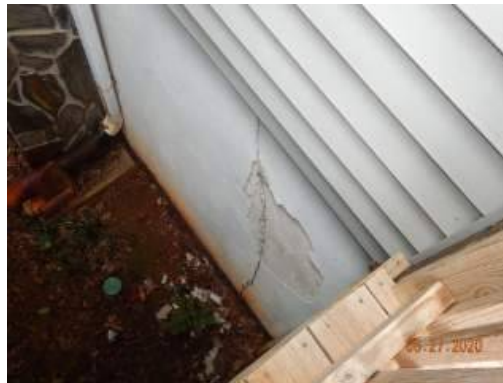
Extensions such as splash blocks or drain pipes for one or more downspouts were missing, poorly sloped and/or misaligned. Water can accumulate around the building foundation or inside crawl spaces or basements as a result. Recommend that a qualified person install, replace or repair extensions as necessary so rainwater drains away from the structure.

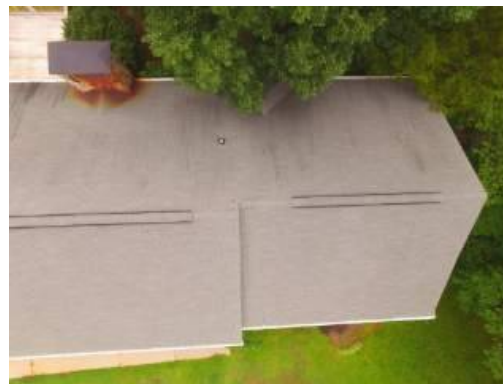
Photo 22-2

Vegetation such as trees, shrubs, and/or vines overhung the roof surface or were in contact with the roof edge. Organic debris such as leaves or needles are likely to accumulate in gutters and on the roof surface. Gutters can overflow and cause water to come in contact with the building exterior or water can accumulate around the foundation. This is a conducive condition for wood-destroying organisms. Vegetation in contact with the roof can damage the roof surface and/or the roof drainage system. Recommend pruning vegetation so as to not be in contact with the roof and to not overhang the roof surface. If vegetation is too tall then it should be pruned at least 10 feet above the roof surface.

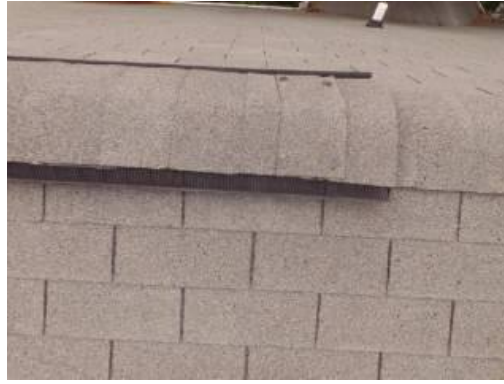
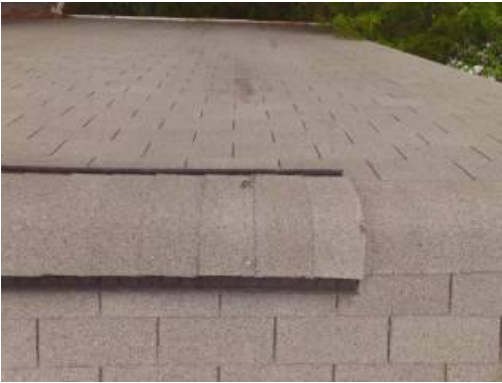
Nail heads were exposed at one or more shingles. More than just a few exposed nail heads may indicate a substandard roof installation. Recommend applying an approved sealant over exposed nail heads now and as necessary in the future to prevent leaks.

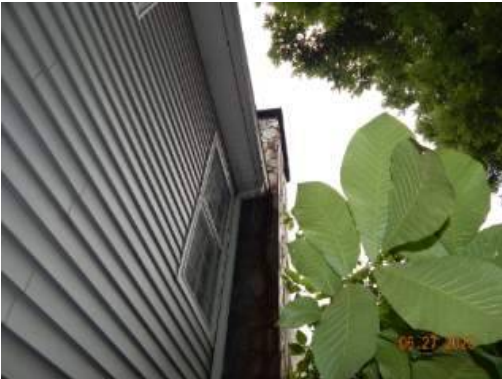
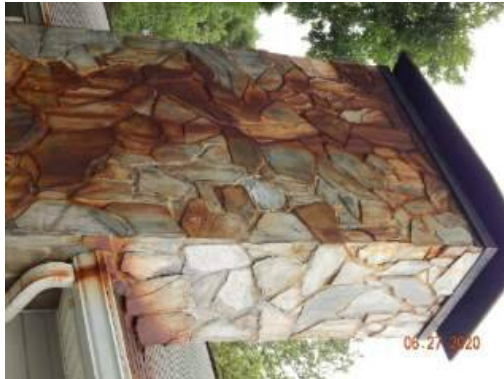
Stains were found at the front of one or more gutters and indicate that the gutters have overflowed. If they have overflowed, it's usually due to debris clogging gutters or downspouts. The inspector was unable to verify that the gutters and downspouts drained adequately due to lack of recent, significant rainfall. Monitor the roof drainage system in the future while it's raining to determine if problems exist. Then if necessary, recommend that a qualified person clean, repair or replace gutters, downspouts and/or extensions.

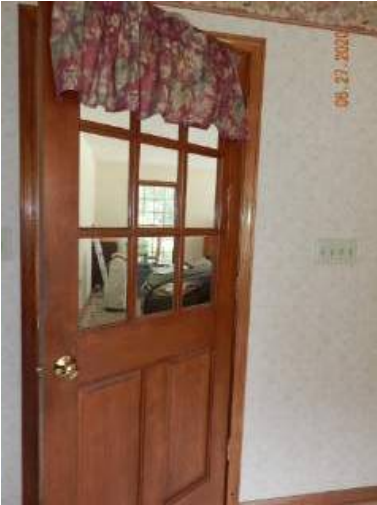
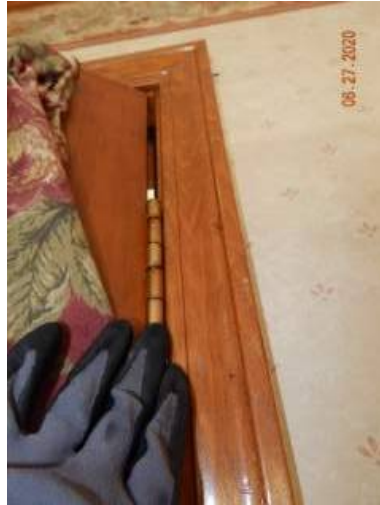
The self-closing device on the door between the garage and the house didn't close and latch the door. These devices are installed to keep the door closed to prevent possible fire and fumes from the garage from spreading to the house. Recommend that a qualified person repair as necessary.

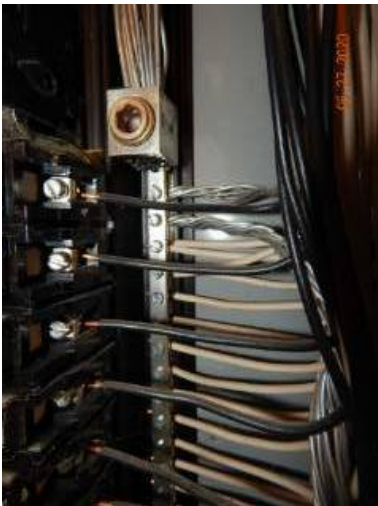
**Photo 38-1**

Neutral wires were doubled or bundled together under the same lug on the neutral bus bar in panel(s) #A. This is a potential safety hazard in the event that one of the circuits needs to be isolated during servicing. For one neutral to be disconnected, other neutrals from energized circuits sharing the same lug will be loosened. Power surges may result on the energized circuits and result in damage or fire. Also, multiple wires under the same lug may not be secure, resulting in loose wires, arcing, sparks and fire. Recommend that a qualified electrician repair per standard building practices. For more information, visit:

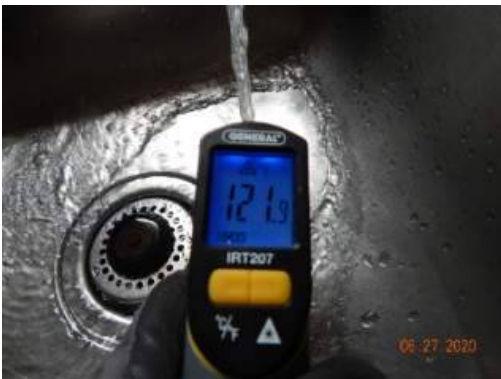
Photo 47-1

The hot water temperature was greater than 120 degrees Fahrenheit. This is a safety hazard due to the risk of scalding. The thermostat should be adjusted so the water temperature doesn't exceed 120 degrees. If the water heater is powered by electricity, a qualified person should perform the adjustment, since covers that expose energized equipment normally need to be removed. For more information on scalding dangers, visit:

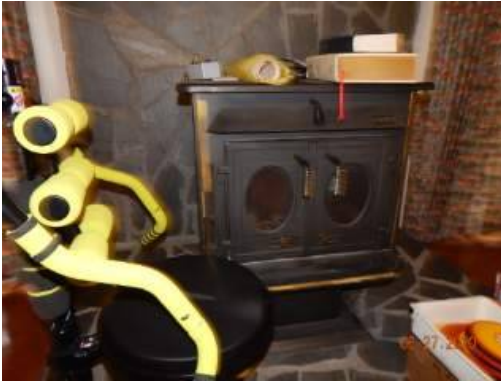
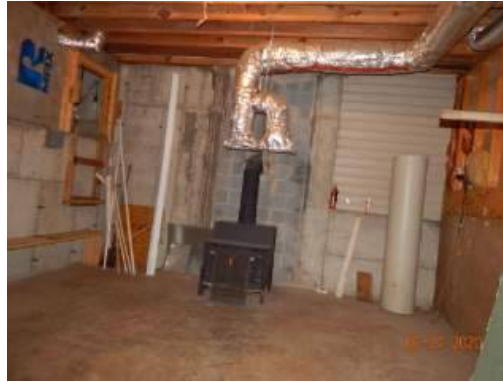
One or more wood stoves appeared to be old and had no visible EPA certification label. Wood stoves not certified by the EPA are typically much less efficient and much more polluting than modern, EPA-certified stoves. Some states, including Oregon, require that wood stoves with no EPA certification be removed when a home is sold. Insurance companies deny coverage because of them. Recommend that a qualified specialist evaluate to determine if the stove is certified, and to determine if it's installed safely. Recommend removing or replacing wood stoves that are not EPA-certified. For more information, visit:

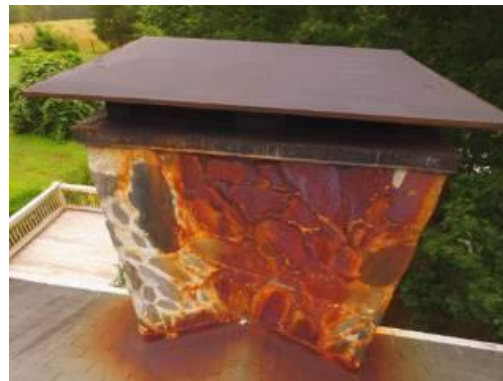
Photo 56-2

One or more metal flue caps for B-vent or L-vent flues were corroded. Such metal flues should terminate with a bird-proof and weatherproof cap. Recommend that a qualified person repair per standard building practices

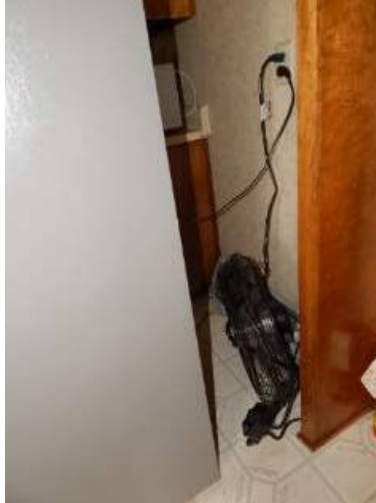
Photo 58-2

The refrigerator was Being serviced. Recommend that a qualified person repair as necessary. The refrigerator may need replacing.

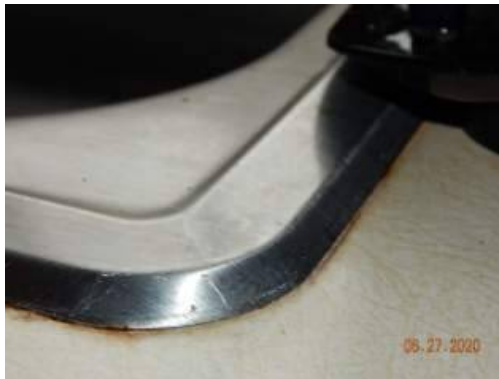
Photo 59-2

Gaps, no caulk, or substandard caulking were found around the sink. Water may penetrate these areas and cause damage. Recommend that a qualified person repair as necessary. For example, by installing caulk.

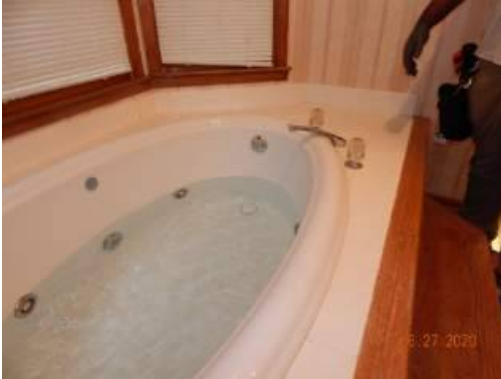
**Photo 60-1**

No ground fault circuit interrupter (GFCI) protection device was visible for the electric supply to the jetted bathtub. If no GFCI protection exists, then this is a safety hazard due to the risk of shock. Recommend that a qualified electrician evaluate and install GFCI protection if none is installed.

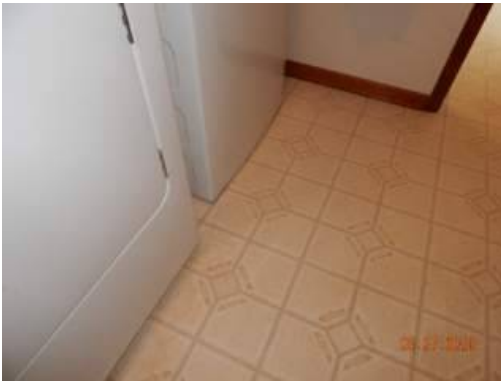
**Photo 61-1**

No catch pan or drain was installed at the clothes washing machine location, and a finished space was located below. Catch pans and drains prevent water damage to finished interior spaces below if or when the washing machine leaks, overflows or is drained. If concerned, consult with a qualified contractor about installing a catch pan. Note that installing a drain line for a catch pan routed to the outdoors may not be feasible. As an alternative, a water alarm can be installed in the catch pan. For more information visit:

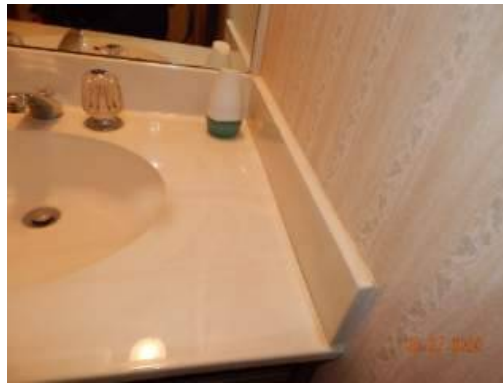
Photo 62-2

Gaps, no caulk, or substandard caulking were found between countertops and backsplashes at location(s) #B. Water can penetrate these areas and cause damage. Recommend that a qualified person repair as necessary. For example, by installing or replacing caulk.

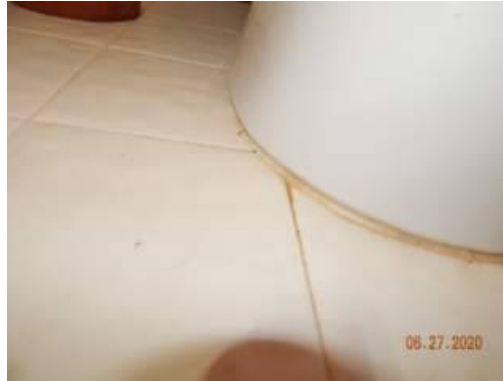
Photo 63-2

Caulk around the base of the toilet at location(s) #B and C was missing, substandard and/or deteriorated. Modern standards require caulk to be installed around the entire toilet base where it meets the floor for sanitary reasons. Without it, soiled water can soak into flooring and sub-floor materials if the toilet overflows. Condensation from the toilet can also soak into the flooring. Recommend that a qualified person caulk around toilet bases per standard building practices.

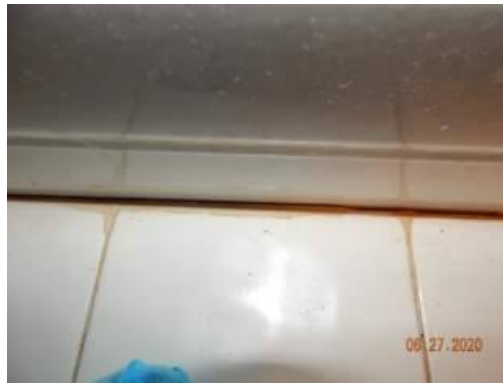
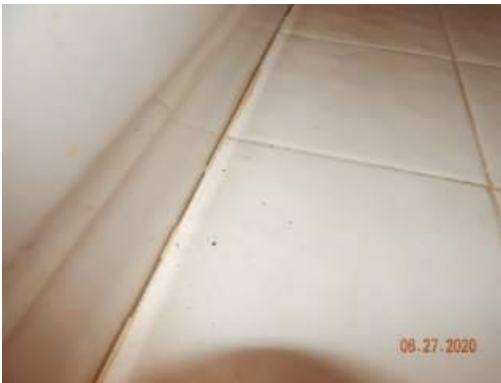
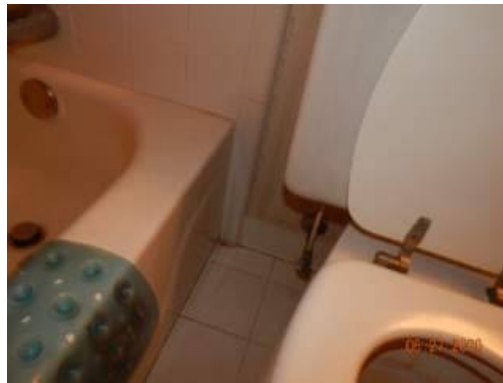
Gaps, no caulk, or substandard caulking were found between the bathtub and the floor and/or walls at location(s) #B. Water may penetrate these areas and cause damage. Recommend that a qualified person re-caulk or install caulking as necessary.

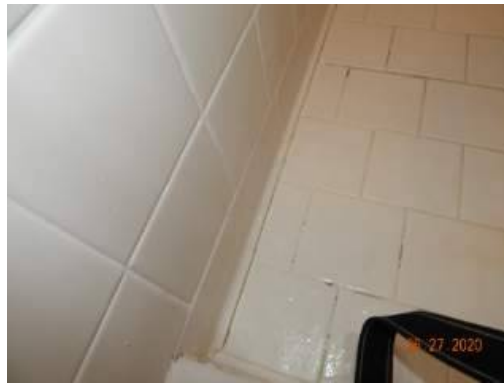
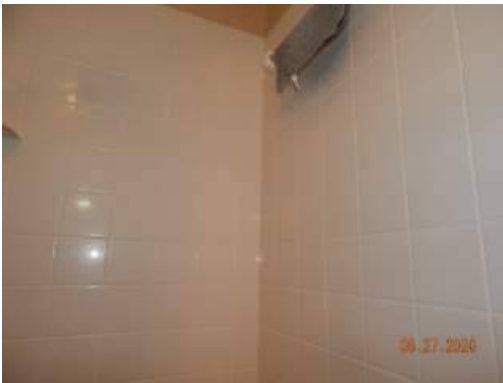
67) 🛠️ Tile, caulk and/or grout in the shower enclosure at location(s) #B and C were deteriorated (e.g. loose or cracked tiles, missing grout) or substandard. Water may leak through gaps and damage the wall or floor structure as a result. Recommend that a qualified contractor repair as necessary. Note that the condition of the structure behind and below the shower enclosure is unknown due to it being concealed.

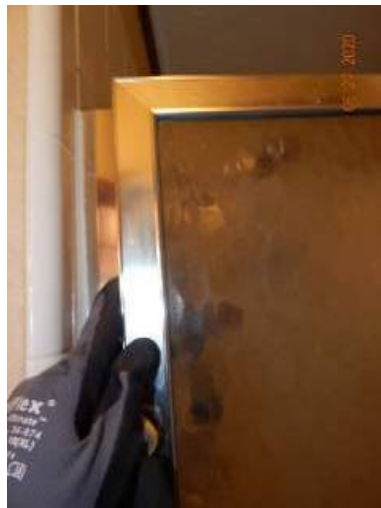
Photo 68-2

68) 🛠️ The shower door at location(s) #C wouldn't latch or close fully. Water can leak out of the enclosure during showers. Recommend that a qualified person repair as necessary.

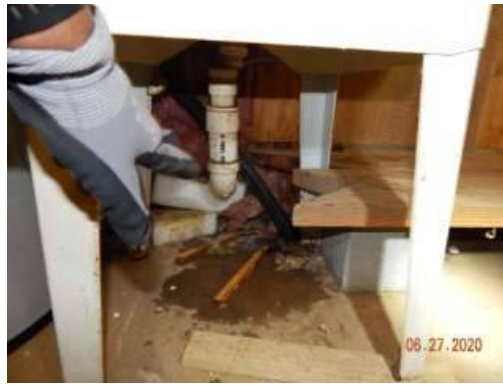
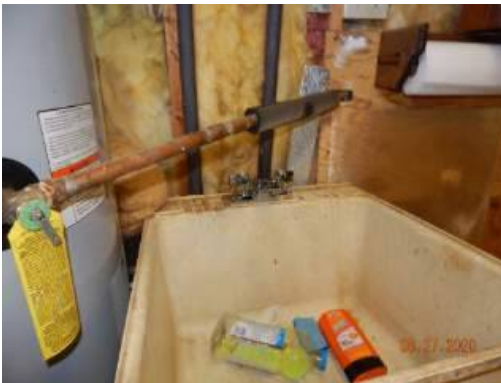
69) 🛠️ The laundry sink drain was leaking. A qualified person should repair as necessary.

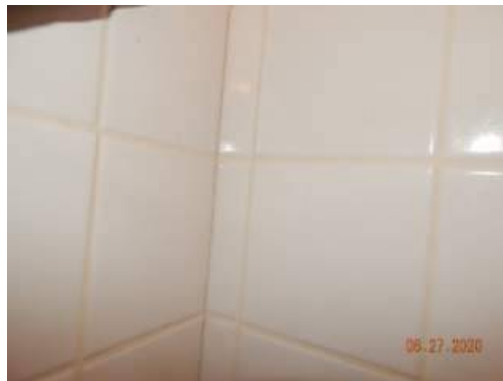
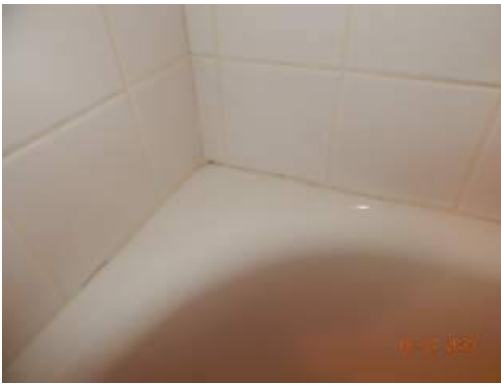
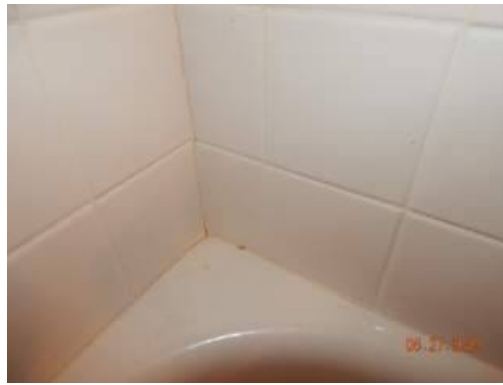
70) 🛠️ Recommend cleaning and sealing the grout in flooring at location(s) #B now and in the future as necessary to prevent staining and to improve waterproofing.

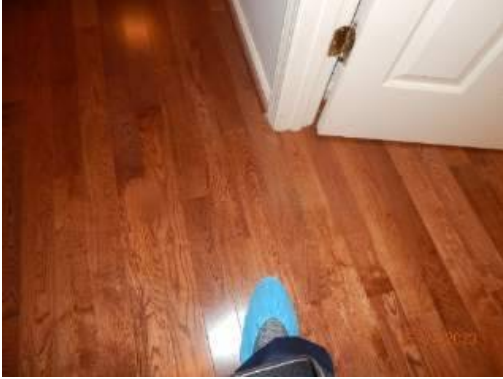
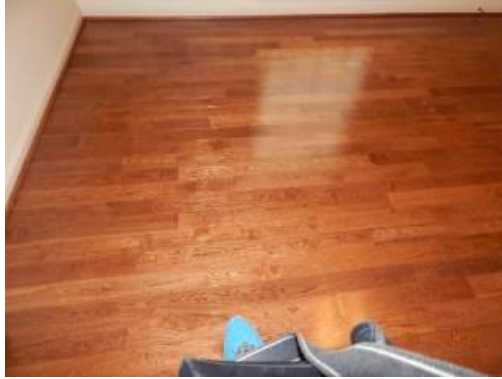
Floors in one or more areas were not level. This can be caused by foundation settlement or movement of the foundation, posts and/or beams. Significant repairs may be needed to make floors level. Recommend that a qualified contractor and/or engineer evaluate further. Repairs should be performed by a qualified contractor.

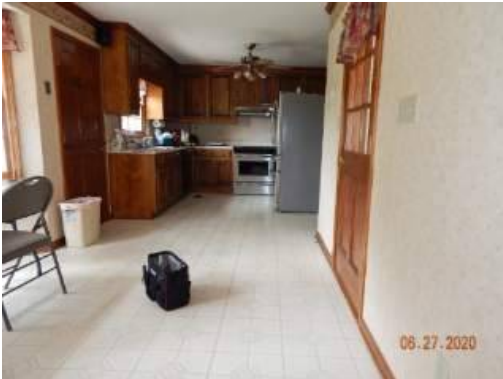
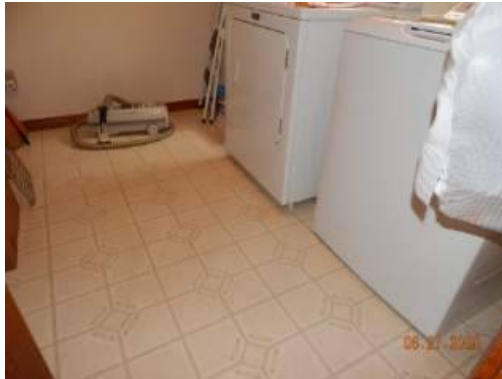
Vinyl floor tiles were installed in one or more "wet" areas (e.g. kitchen, mud room, bathroom, laundry room). Spilled water can penetrate seams and damage the sub-floor. Recommend that a qualified contractor install continuous waterproof flooring in wet areas as necessary.

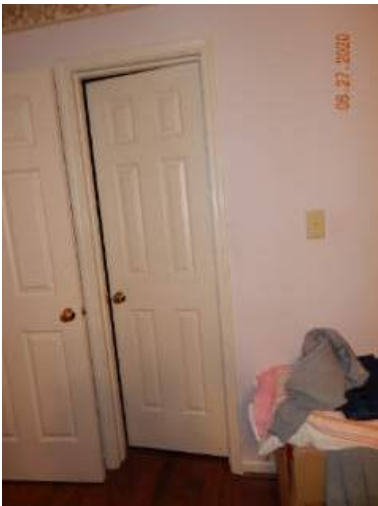
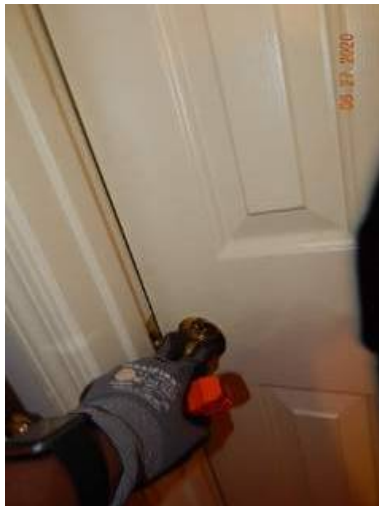
One or more interior doors wouldn't latch or were difficult to latch. Recommend that a qualified person repair as necessary. For example, by adjusting latch plates or locksets.

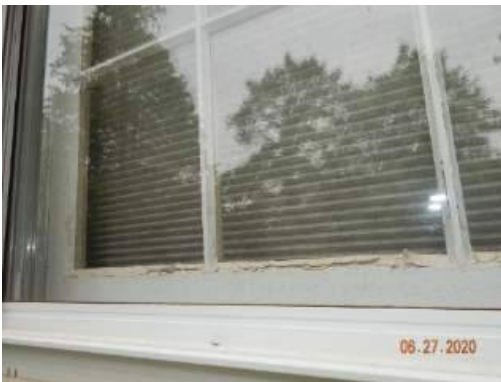
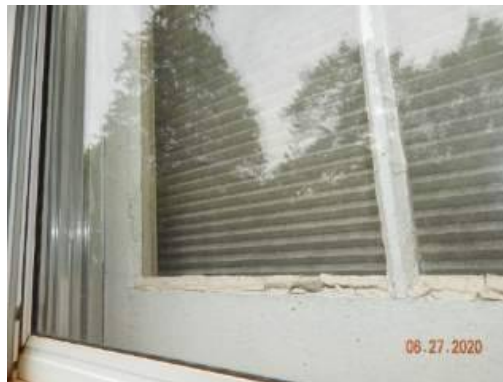
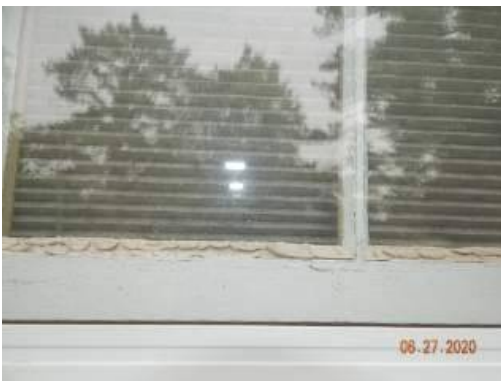
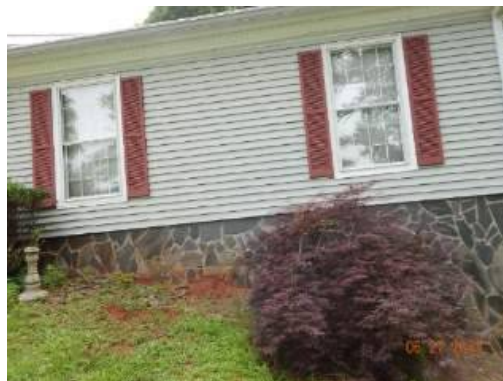
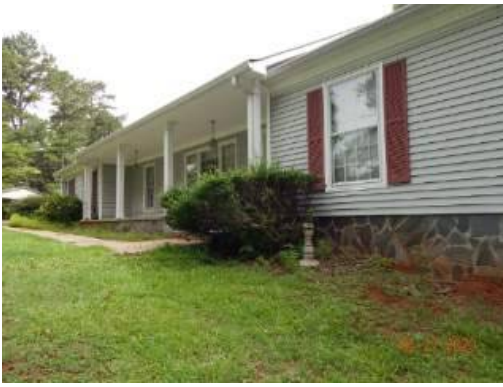
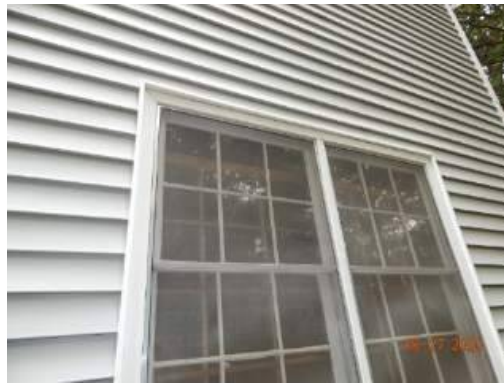
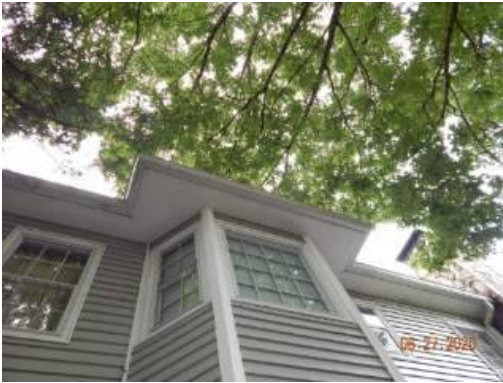
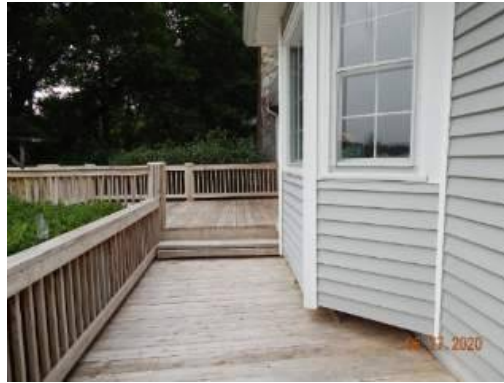
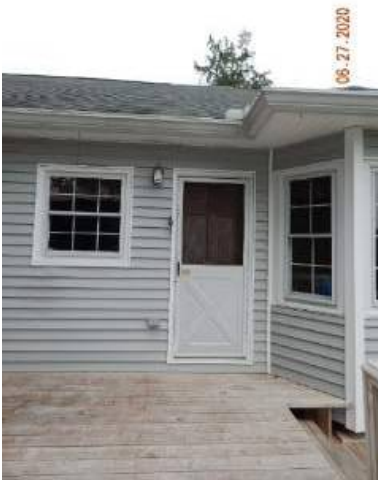
The glazing compound or caulk that holds glass panes in one or more windows was deteriorated and/or substandard. Air and/or water can leak through windows, and wood window frames are prone to rot. This is a conducive condition for wood-destroying organisms. Recommend that a qualified person replace glazing compound as necessary. For more information, visit: <https://www.reporthost.com/?PUTTY>

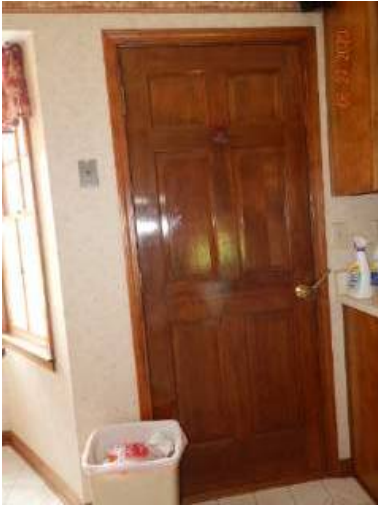
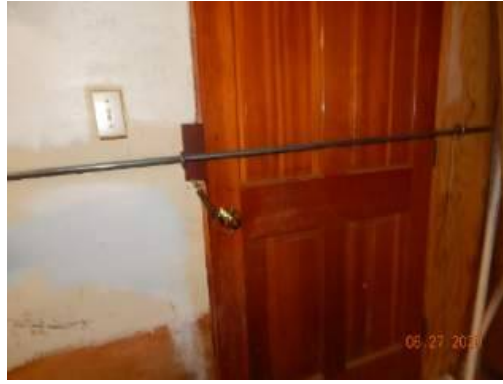
78) ⓘ One or more hinged exterior doors had no deadbolt lock installed and relied solely on the entry lockset for security. Recommend installing locksets on exterior doors where missing for added security.

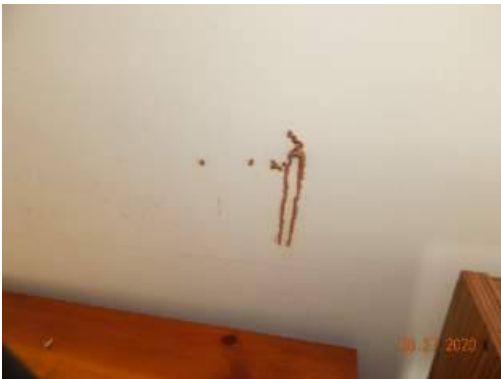
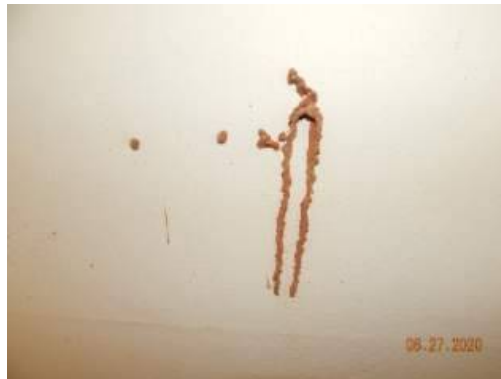
Evidence of past infestation of subterranean termites was found at location(s) #A in the form of mud tubes with no visible wood damage. Recommend the following:

- Correct any conducive conditions for wood-destroying organisms mentioned in this report.
- Consult with the property owner about any history of infestation.
- Have a state-licensed pest control operator evaluate further and treat as necessary.

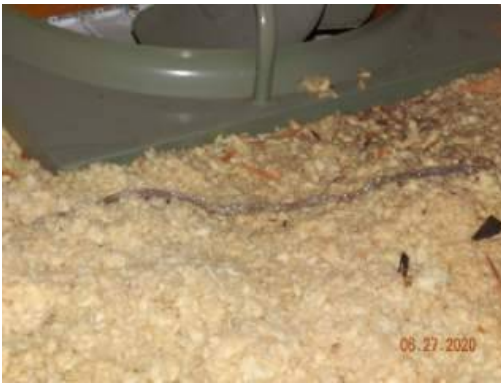
Photo 80-1

One or more snakes skin(s) was observed in the attic at the time of the inspection. Recommend having a pest control/ wildlife company evaluate further.
