3rd EYE HOME INSPECTION, LLC Inspection Report

Client(s): **New Construction Sample Report**

Property address: **111 Sample Report Ln 2
Jonesboro, GA 30000**

Inspection date: **Tuesday, January 19, 2021**

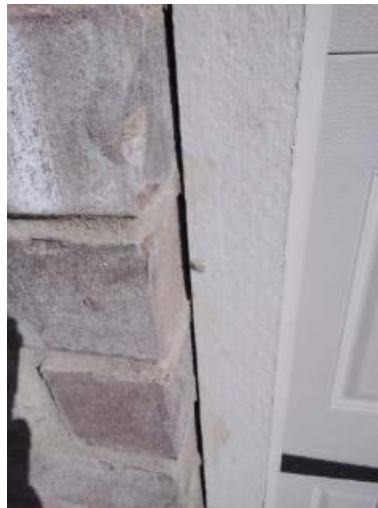
Photo 2-2

Caulk was missing in some areas. For example, at siding butt joints and/or at wall penetrations. Recommend that a qualified person renew or install caulk as necessary. Where gaps are wider than 1/4 inch, an appropriate material other than caulk should be used. For more information, visit:

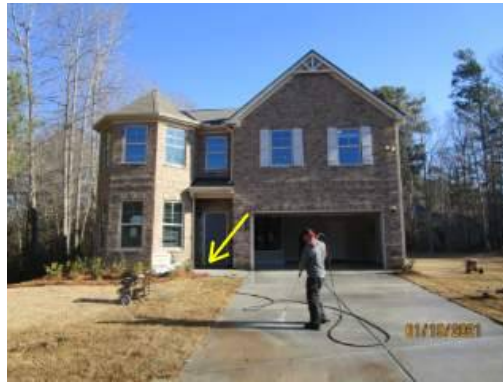
Photo 3-2

Extensions such as splash blocks or drain pipes for one or more downspouts were poorly sloped and/or misaligned. Water can accumulate around the building foundation or inside crawl spaces or basements as a result. Recommend that a qualified person install, replace or repair extensions as necessary so rainwater drains away from the structure.

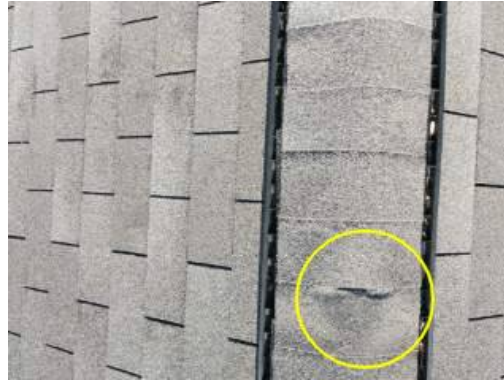
Photo 4-2

Some composition shingles were Minor impressions. Leaks can occur as a result. This is a conducive condition for wood-destroying organisms. Recommend that a qualified contractor repair as necessary. For example, by replacing shingles.

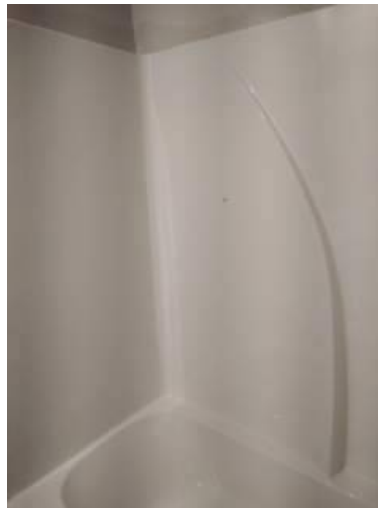
Photo 20-2

The bathtub at location(s) #A, and #D was worn, blemished or deteriorated.

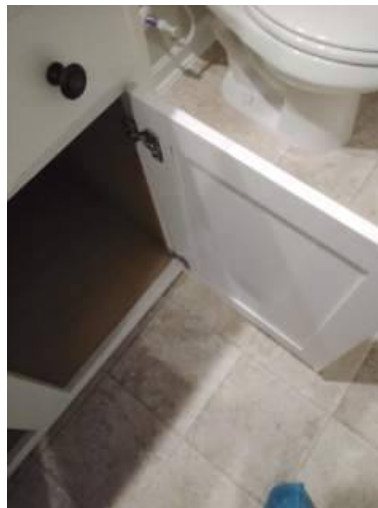
Photo 22-2

One or more cabinets, drawers and/or cabinet doors at location(s) #A, B and D were loose. Recommend that a qualified person repair or replace as necessary.

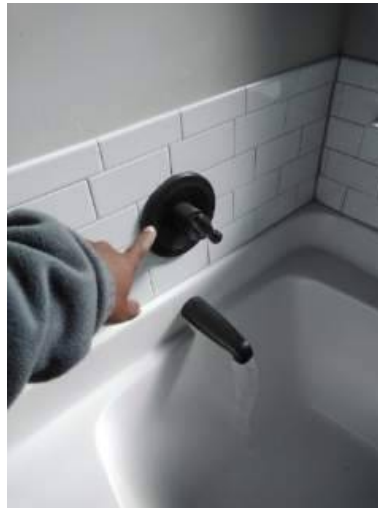
**Photo 23-2**

Caulk was missing around the base of the bathtub spout, or there was a gap behind it, at location(s) #B. Water may enter the wall structure behind the bathtub. Recommend that a qualified person repair as necessary to eliminate the gap. For example, by installing or replacing caulk if the gap is small enough. For larger gaps, a shorter spout nipple or an escutcheon plate can be installed.

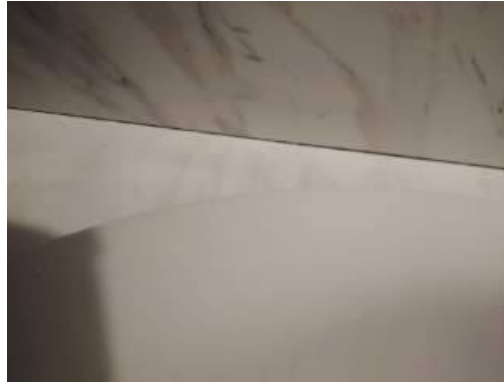
Photo 24-2

Gaps, no caulk, or substandard caulking were found between countertops and backsplashes and/or around the sink at location(s) #A, B and D. Water can penetrate these areas and cause damage. Recommend that a qualified person repair as necessary. For example, by installing or replacing caulk.

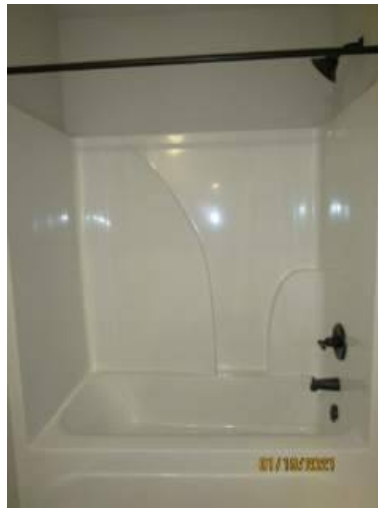
Photo 25-2

Gaps, no caulk, or substandard caulking were found between the shower enclosure and the walls at location(s) #A and D. Water can penetrate these areas and cause damage. Recommend that a qualified person re-caulk or install caulking as necessary.

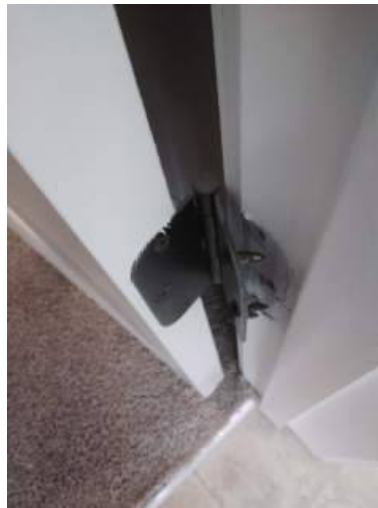
Photo 29-2 The master bedroom closet.

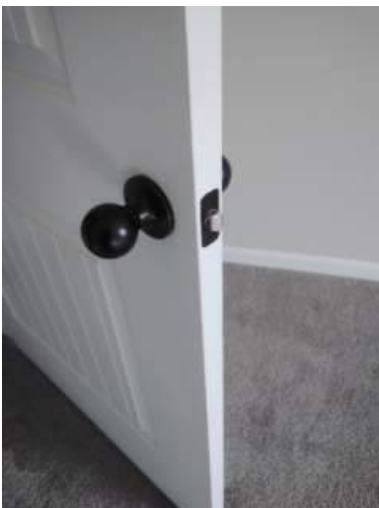
Photo 29-3 The NW bedroom closet.

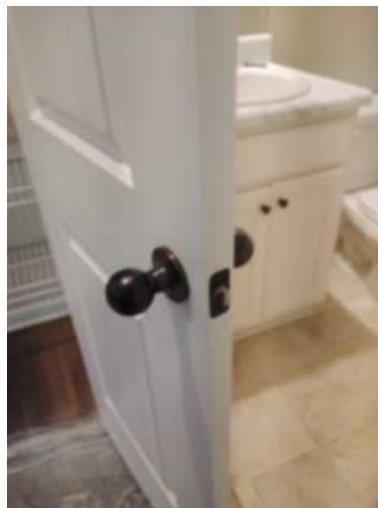
Photo 29-4 The downstairs closet near bathroom.

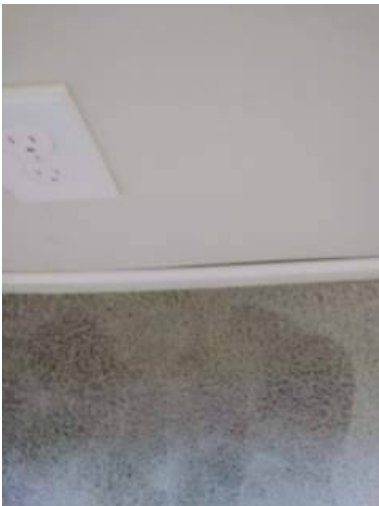
Photo 34-3

Trim was loose, missing and/or damaged in one or more areas. Recommend that a qualified person repair as necessary.

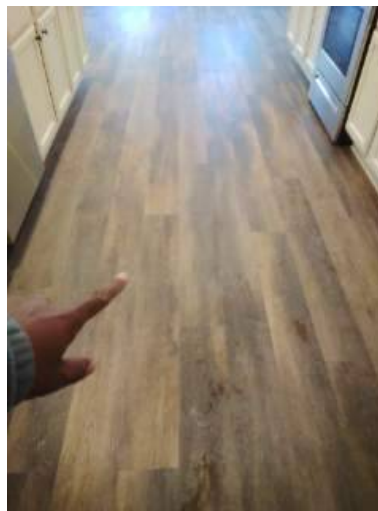
Photo 36-2

Vinyl, linoleum or marmoleum flooring in one or more areas was loose and/or Loose. If in a wet area, water can damage the sub-floor as a result. Recommend that a qualified contractor replace or repair flooring as necessary.

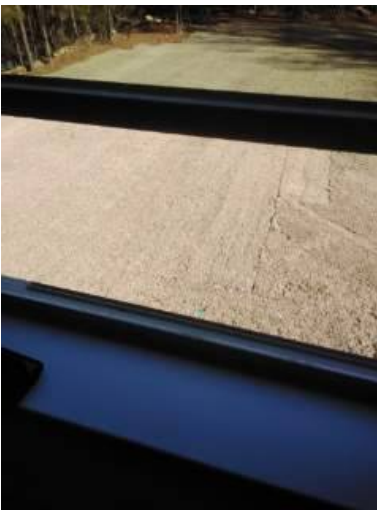
Photo 38-1

No window screens were installed. Windows may not provide ventilation during months when insects are active.
